General Structural Assessment of Several Structures at the Armed Forces Retirement Home

Barnes Building, Hostess House, Forwood
Building, Mess Hall, Mess Hall Corridor, and
King Hall

May 30, 2018

Stantec Consulting Services Inc.

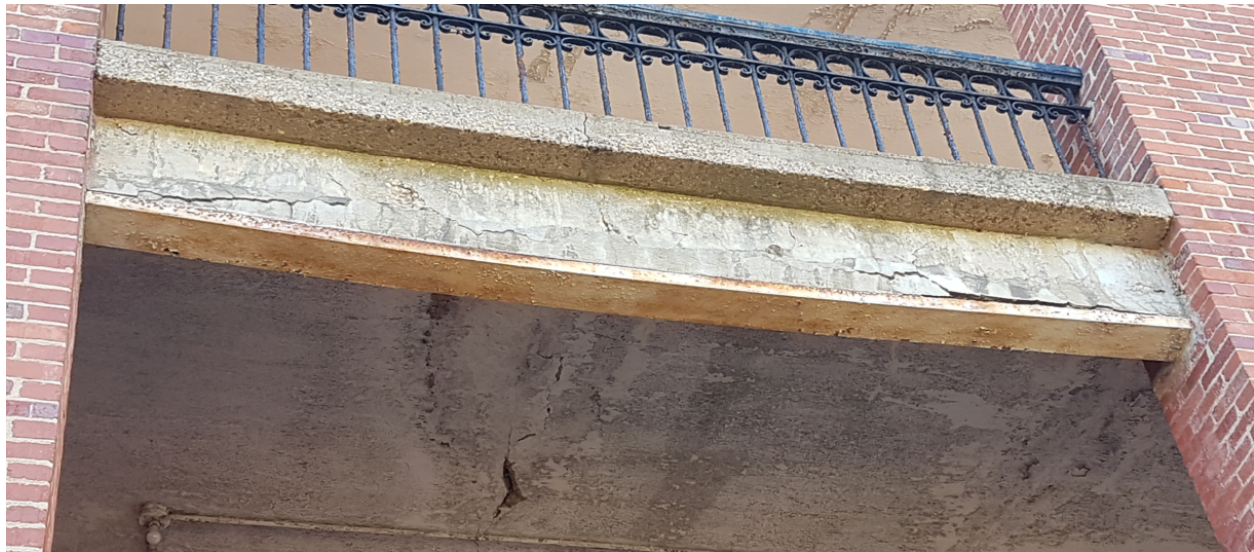
During the site observation, Stantec observed some areas of concern at the Barnes Building. However, many of the structural components were in good condition. The roof is in good condition because the roof decks are made of concrete with steel support beams, which is more water resistant than most of the wooden roofs present on site. Stantec observed that concrete infill at the steel beams around the porch perimeter of the building have experienced water infiltration causing the encased steel beams to warp and the infill concrete to spall and crack (see Figure 37 below). There are eight encased beams in total that show signs of warping. It was noted that the wooden fascia, soffits, garage doors, and window frames for Barnes evidence deterioration due to water infiltration (see Figures 38 and 39). The brick walls were observed to have no cracking or other structural issues (see Figure 39).

FIGURE 37: EXTERIOR STEEL BEAM WARPING AND CONCRETE SPALLING AT BARNES 2ND FLOOR EAST SIDE

The condition of King Hall indicates that it may have been in good condition and may have been occupied/maintained more recently than the other buildings. Like the other buildings on the site, the wooden soffits, fascia, and window frames are weathered/deteriorated. In addition, there were eight exterior porch support beams, on the 2nd floor, that are warping from water infiltrating the concrete encasement. Prior to construction, the concrete encasement should be removed, and the beams should be further evaluated by a structural engineer.

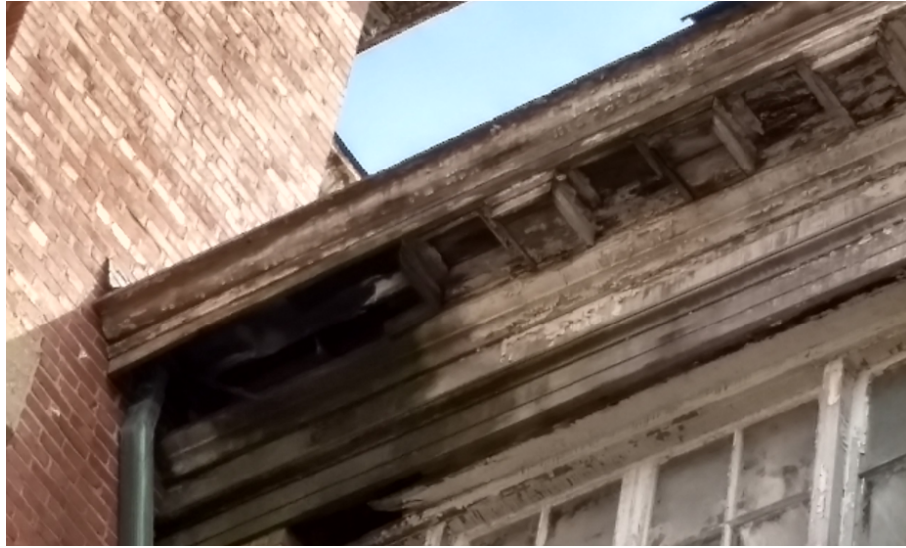
FIGURE 38: DETERIORATED SOFFIT AT BARNES

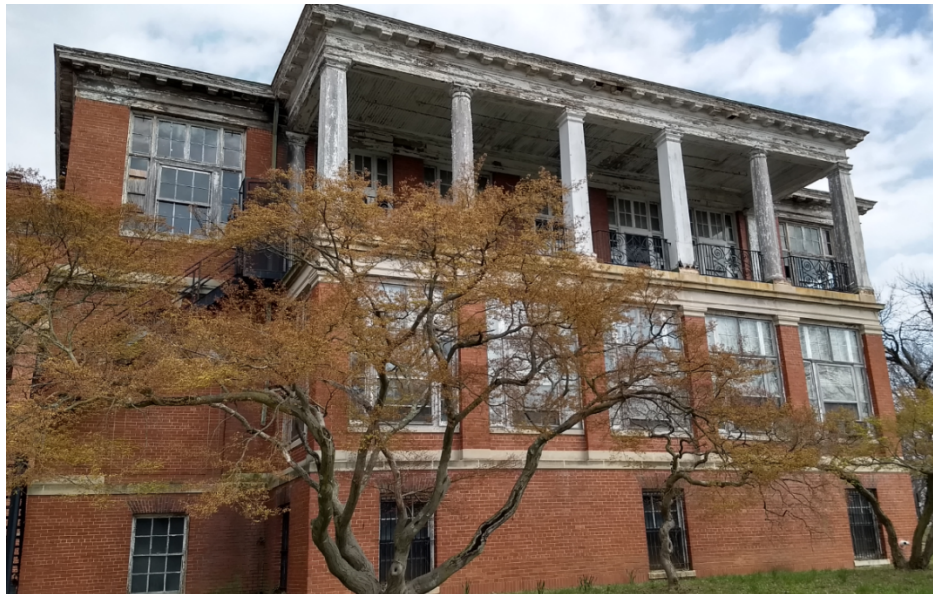
FIGURE 39: DETERIORATED SOFFIT & GOOD CONDITION BRICK WALLS AT BARNES

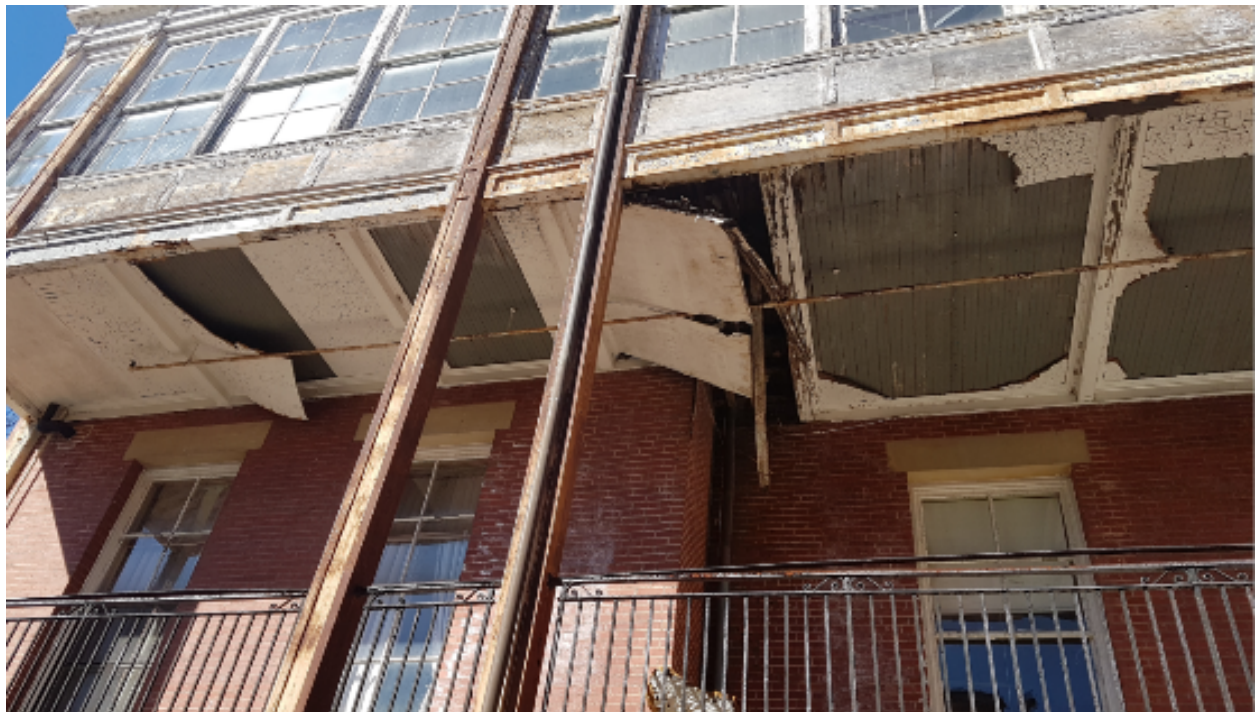
Several field observations were made about the Forwood Building. The south side of the building has a wooden sun porch that has deteriorated significantly (see Figure 40 below). Also, similar to other buildings at the site, the wooden fascia, soffits, and window trim are also deteriorating from old age and water damage. Water intrusion occurring at the solariums on the east and west sides of the building was also observed. Water infiltration, at all three floors, has caused mold to grow on the structural tile and has deteriorated grout in between the tiles (see Figure 41 below). The clay tile and steel beam roof of Forwood was observed to be in good shape, however, the flat roof portions of the roof over the solariums are leaking and causing water damage on the floors below. Stantec estimates a total of 1,400 square feet of floor tile will need to be replaced only at the solariums. Where exposed, structural tile in the rest of the building appeared in good condition. Similar to the other buildings on site, Stantec observed no cracking on the exterior brick elements and the wooden clocktower structure was in good condition.

FIGURE 40: DETERIORATED SUN ROOM SOUTH SIDE OF FORWOOD

Most of the floors, roofs, and the brick exterior of Forwood are in good shape structurally. Many of Forwood's exterior wood elements such as the soffits, fascia, and window frames are weathering, and the wooden porches (sunrooms) are structurally unsafe. Water intrusion has caused mold and deteriorating grout that has caused damage to the structural clay tile. These tiles could have interior damage such as rusting/deteriorating tie rods and loss of connection to the tie rods. If the tie rods are damaged or are no longer connected to the tile, the floors would have a major loss of structural capacity. The amount of damaged structural clay tile observed amounts to approximately 1,400 square feet.

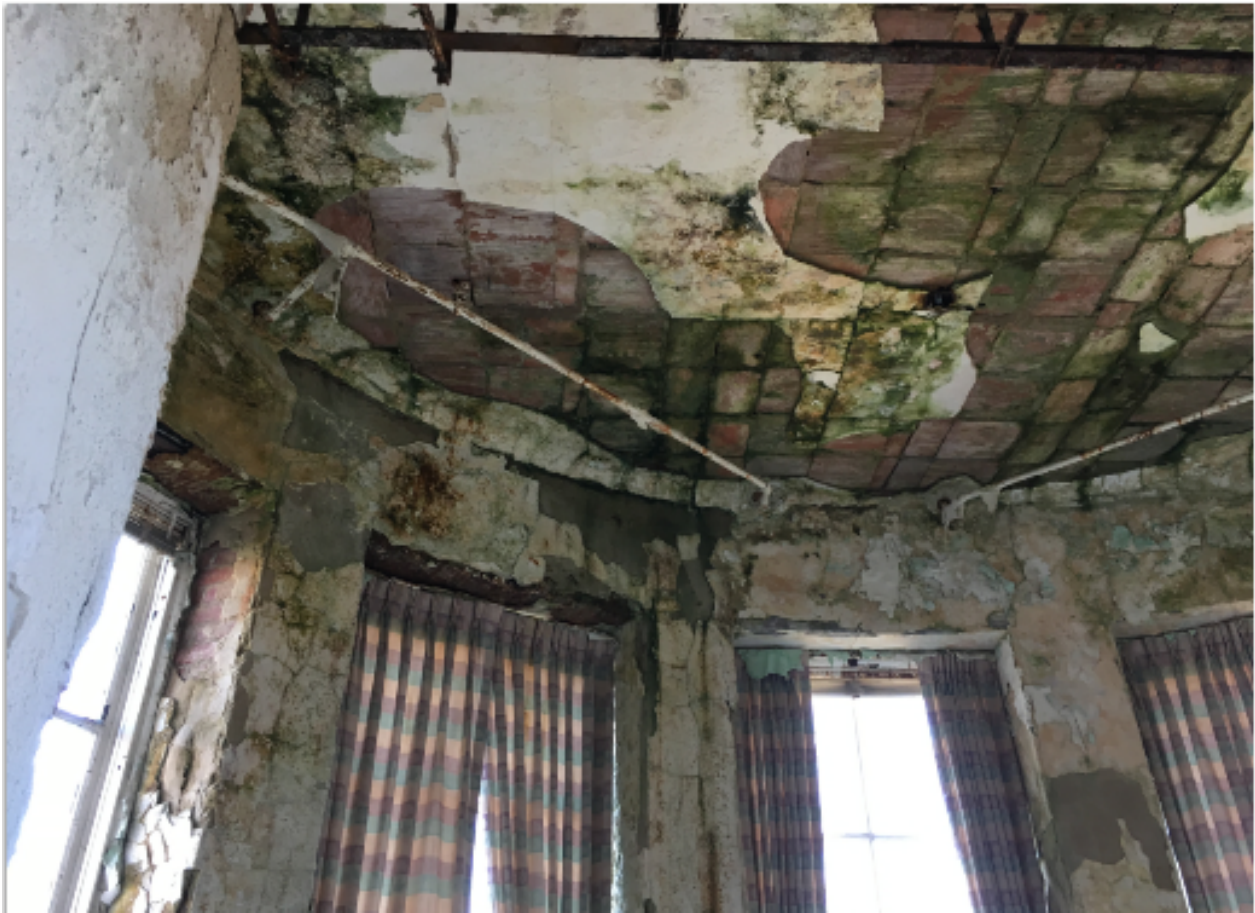
FIGURE 41: WATER DAMAGE AT THE FORWOOD SOLARIUM CEILING

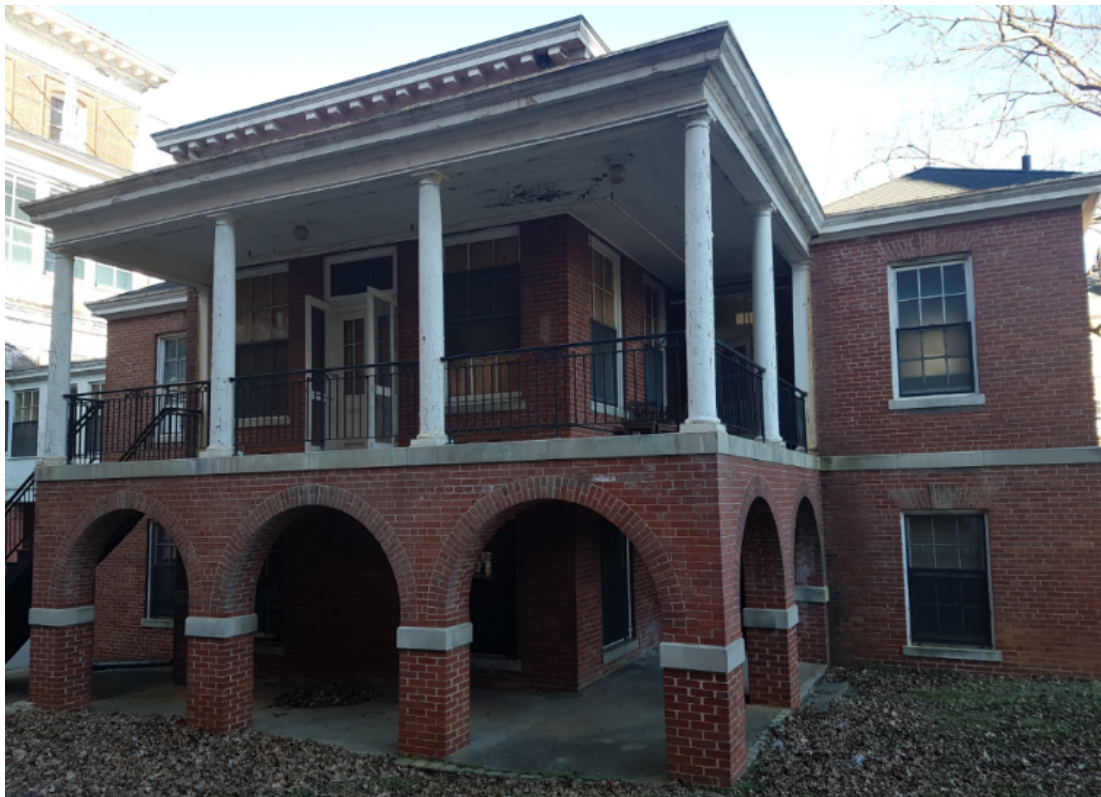
There were relatively few noticeable defects in the Hostess House. The brick exterior was observed to be in good condition (see Figure 42). Stantec observed deterioration of the wooden soffits, fascia, and window frames, which is typical throughout the site. In addition, the wooden exterior of the walkway that connects the Hostess House to Forwood is severely weathered (see Figure 43). The roof of the Hostess House was difficult to access and was not inspected. Water intrusion was not observed in the Hostess House. However, some of the roof drains were not shedding storm water away from the building effectively (see Figure 44).

FIGURE 42: EXTERIOR OF HOSTESS HOUSE AT WEST SIDE SHOWING INTACT BRICK EXTERIOR

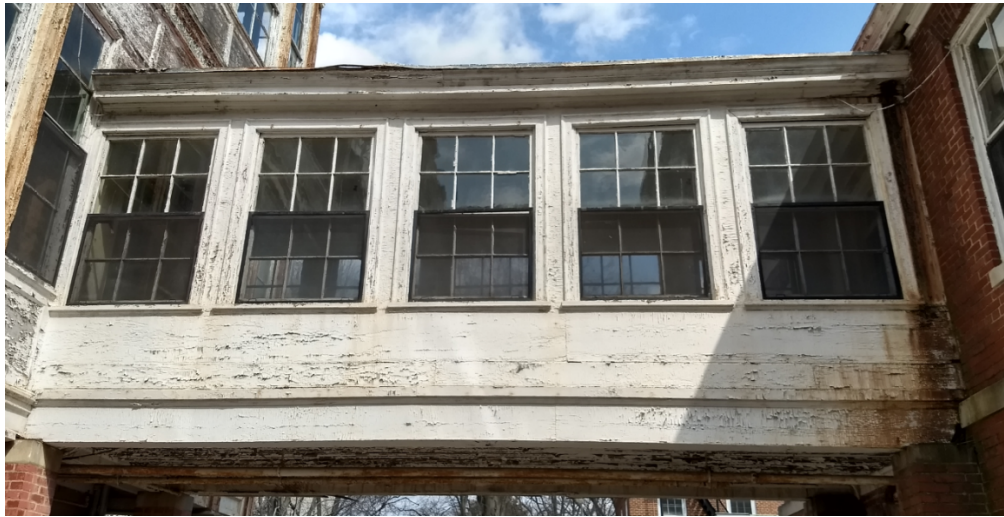
FIGURE 43: HOSTESS HOUSE WALKWAY TO FORWOOD SHOWING WOOD DETERIORATION

The structure of the Hostess House was generally in good condition. The wooden soffits, the fascia, the wooden exterior of the walkway and the window frames show signs of weathering and deterioration. The wooden exterior of the walkway that connects the Hostess House to Forwood is showing signs of weathering/deterioration, and some of the gutters and downspouts will need to be cleaned and repaired. Finally, a qualified roof inspector should be hired to inspect the roof to insure no leakage.

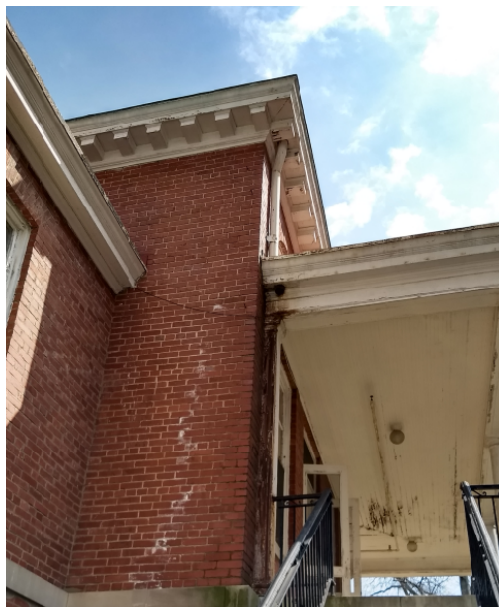
FIGURE 44: STORM DRAIN NOT SHEDDING WATER EFFECTIVELY AT HOSTESS HOUSE

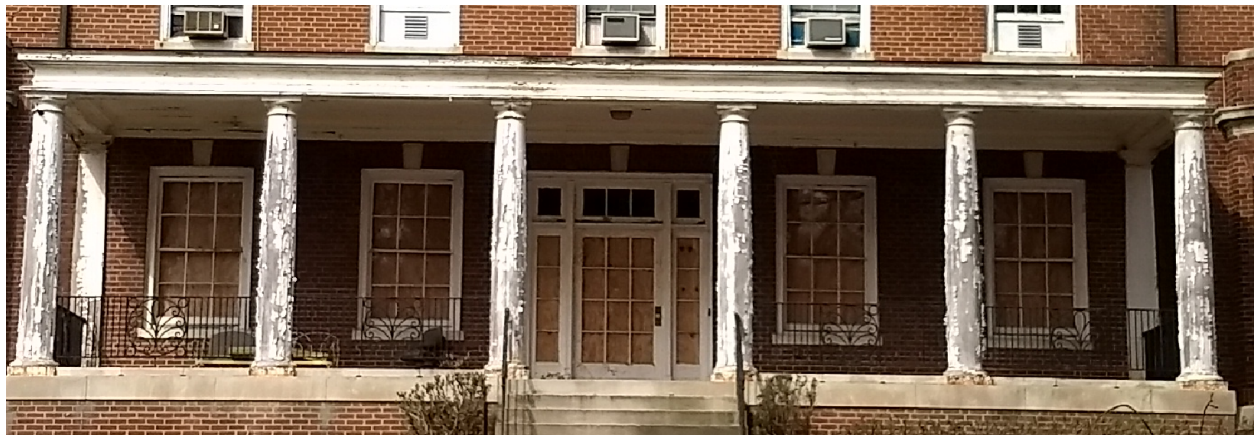
Stantec observed that the King Hall Building has the same issues that are typical to the site including wooden soffits, fascia, wooden porches, and window frames that have been weathered and deteriorated (see Figure 45). However, the main structure of King Hall, including the brick exterior, was observed to be sound (see Figure 46). From what Stantec observed, the roof did not evidence substantial water infiltration. The wooden floors and inside portion of the brick walls were not accessible for viewing; however, the interior finishes did not show any signs of water damage or mold (see Figure 47). These observations show that King Hall is still shedding water effectively.

FIGURE 45: WOODEN EXTERIOR PORCH SOFFIT SHOWING SIGNS OF WEATHERING AND DETERIORATION

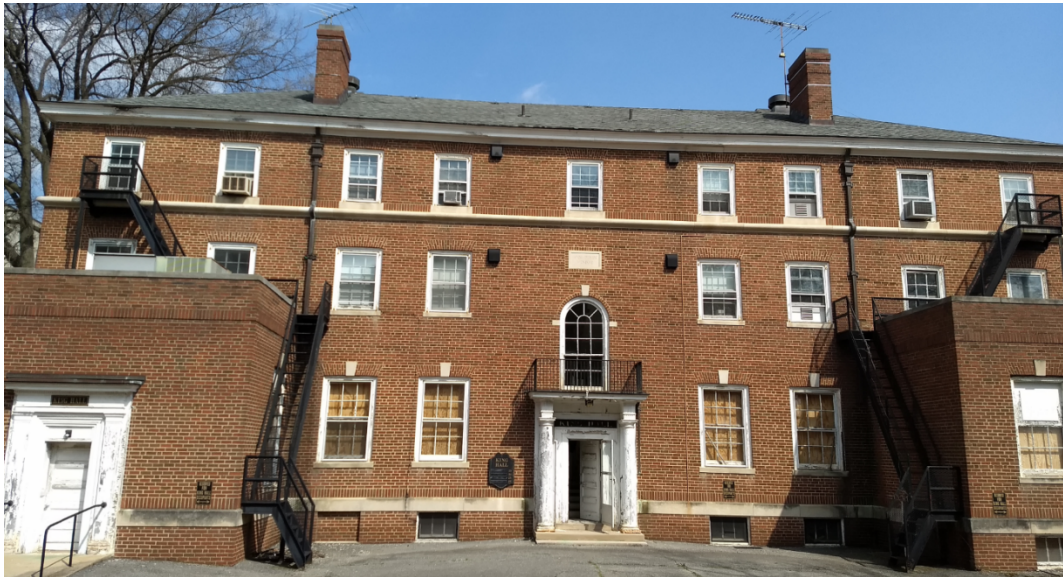
FIGURE 46: EXTERIOR PHOTOGRAPH OF KING HALL BUILDING SHOWING INTACT BRICK WORK

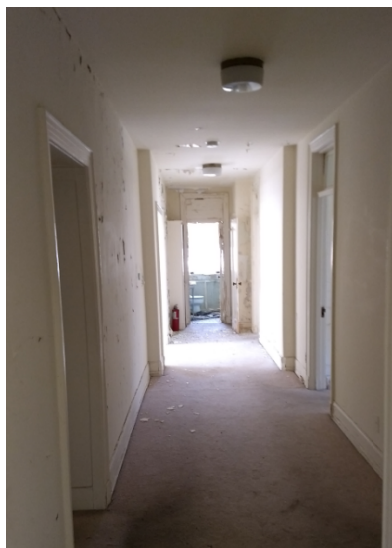
FIGURE 47: INTERIOR KING HALL HALLWAY WITH RELATIVELY INTACT FINISHES AND NO WATER INTRUSION

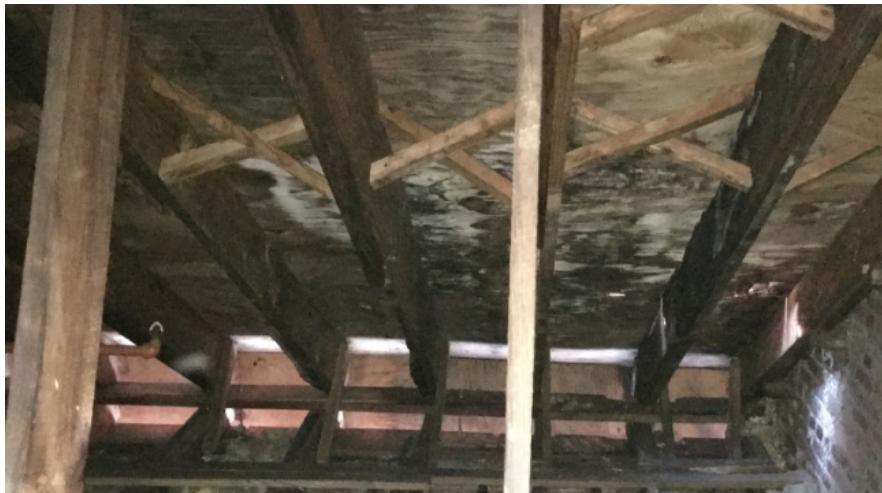
The Mess Hall has several issues that were observed during the site investigation. The wooden exterior elements such as the soffit, fascia, and window frames are deteriorated. In addition, the wooden trusses in the dining hall were observed to be rotted from water intrusion. The roof has holes and is missing shingles (see Figure 48 and Figure 49), which is causing the water intrusion. Water intrusion into the building is also being caused by missing windows. The steel florestyle pans that are supporting the floor are rusting, becoming thinner, and in some places the pans have broken apart at their ribs (see Figure 50 and Figure 51). Stantec observed mold throughout the basement which is further evidence of poor air circulation and water intrusion (see Figure 52).

FIGURE 48: ROTTING WOOD SHEATHING, MISSING SHINGLES, AND ROTTING WOOD BEAMS AT MESS HALL ROOF

The Mess Hall has multiple problem areas caused by water intrusion into the building. The roof has holes and is missing shingles. A full inspection of the roof should be done to determine the location of all leaks in the roof and how much of the wooden structure has been impacted. Rotting wood sheathing and rotting wooden beams are present throughout the roof structure. Broken windows are also contributing to the water infiltration. There is a shrinkage crack on the south east corner that will need to be repaired. Also, the steel florestyle pans that support the floors are rusting and splitting. The floor will need to be investigated further to determine how extensive the rusting and splitting is and how much of a loss in structural capacity the floor has. In addition, the wooden exterior items such as the fascia, soffit, and window frames are deteriorated.

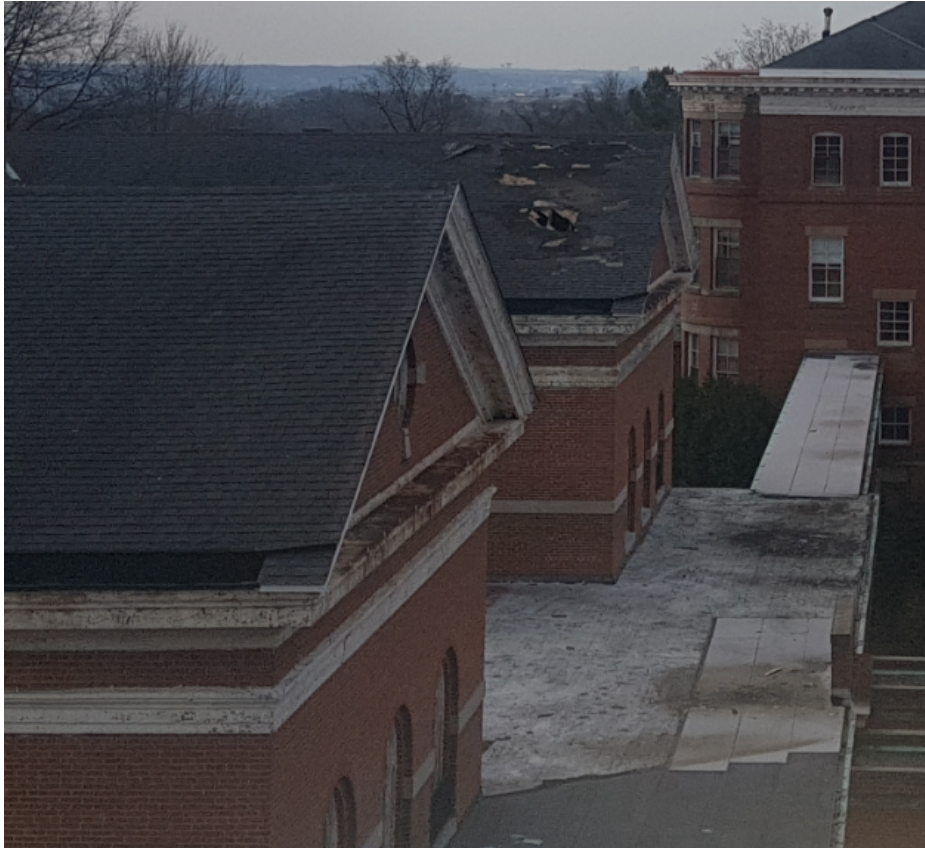
FIGURE 49: HOLE IN MESS HALL ROOF AND DAMAGED ROOFING AT MESS HALL CORRIDOR

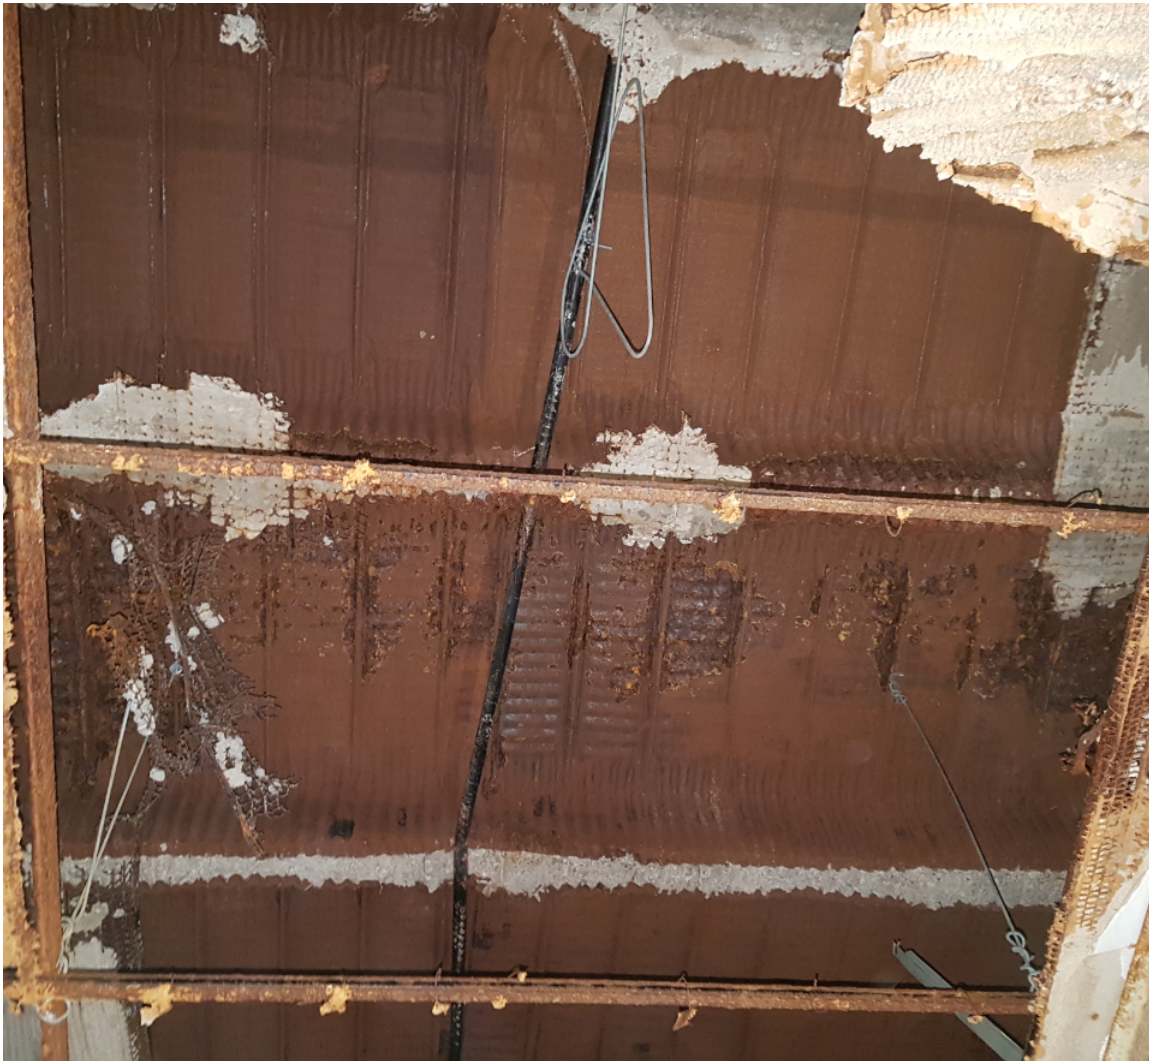
FIGURE 50: SPLITTING AND RUSTING STEEL FLORESTYLE PANS AT MESS HALL 1ST FLOOR

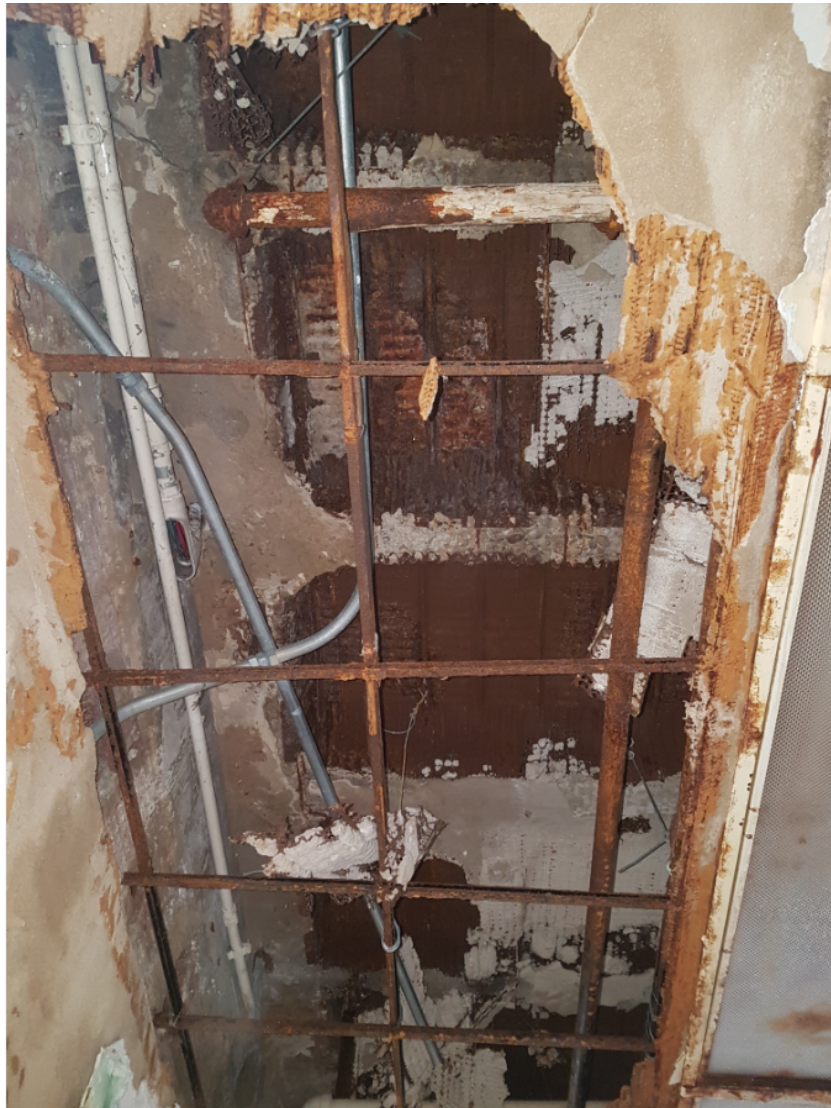
FIGURE 51: SPLITTING AND RUSTING FLOOR STEEL FLORESTYLE PANS

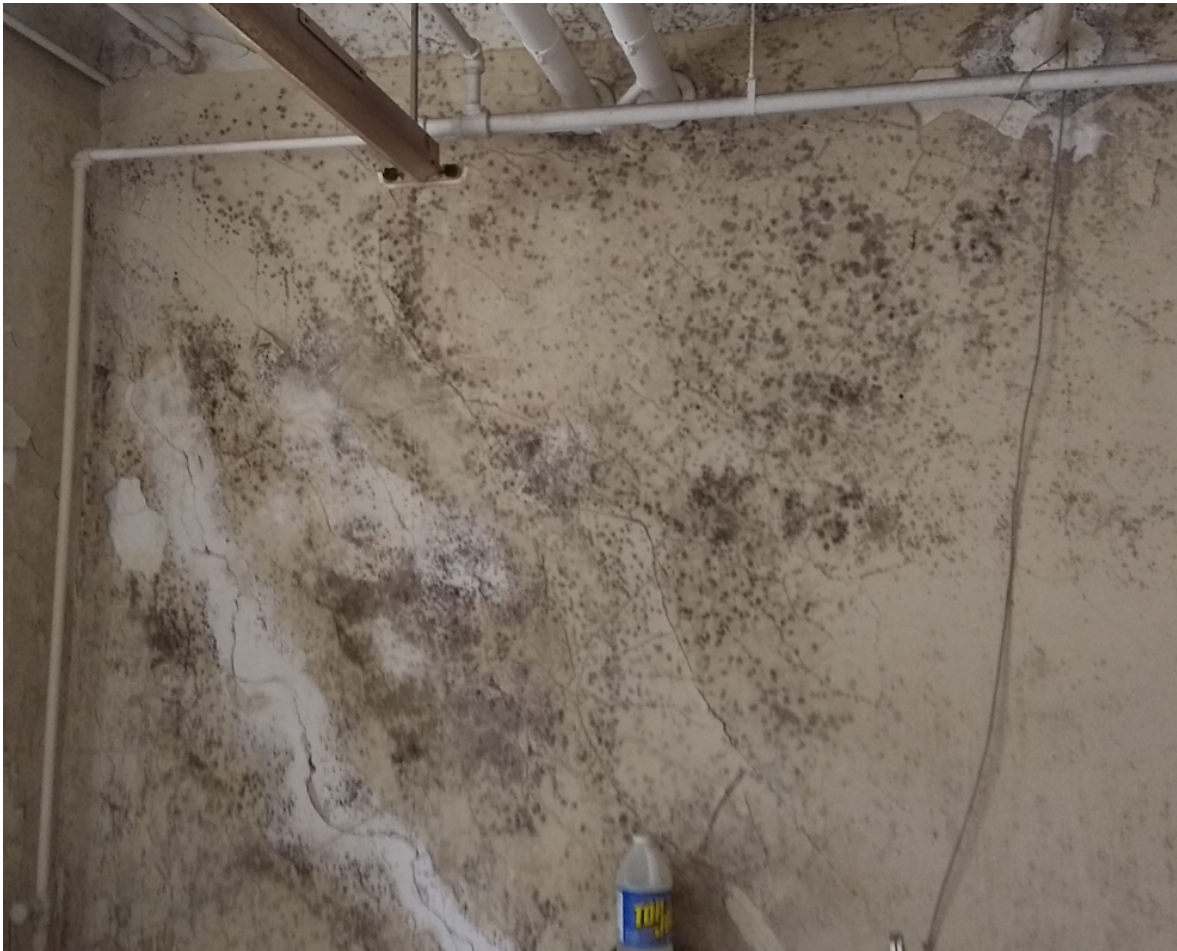
FIGURE 52: MOLD IN MESS HALL BASEMENT

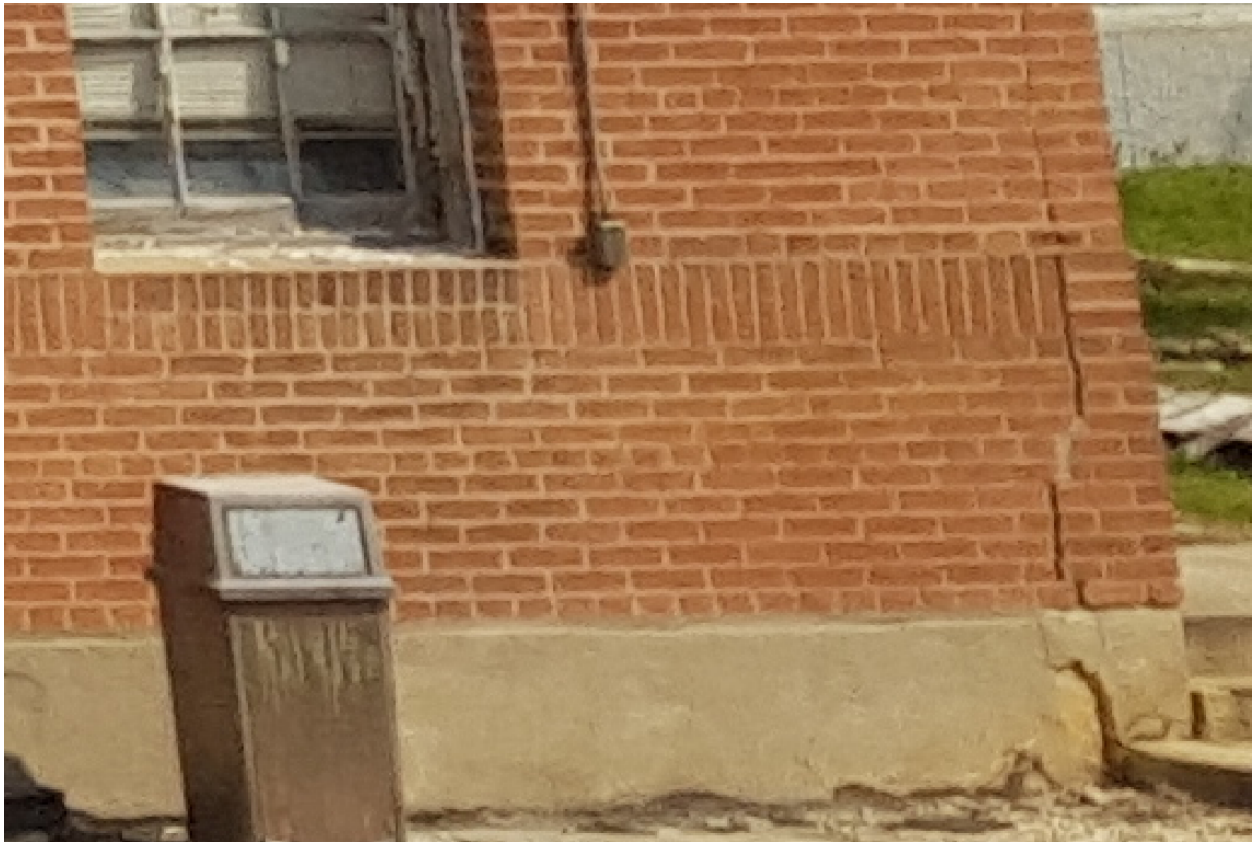
On the exterior of the building, there is a crack in the south east corner of the building that is due to shrinkage of the concrete foundation wall. When the concrete foundation wall cured, the wall cracked due to an insufficient amount of horizontal reinforcing in the wall. This crack grew larger over time due to water infiltrating the crack and freezing, causing the crack to expand. Having the basement unheated for an extended period of time would help the water to freeze. In addition, there is a “pocket” between the stairs and the wall where snow collects and infiltrates the crack. The bricks above the wall have cracked due to a lack of a bond break between the concrete and the brick. As the concrete expanded, the friction between the concrete and brick transferred the crack to the brick (See Figure 53). Finally, the roof over the Mess Hall corridor, as seen in Figure 49 and 54, is inadequate and or is compromised, and water is infiltrating the roof, causing damage to the roof structure.

FIGURE 53: VERTICAL CRACK CAUSED BY SHRINKAGE AT MESS HALL SOUTH EAST CORNER

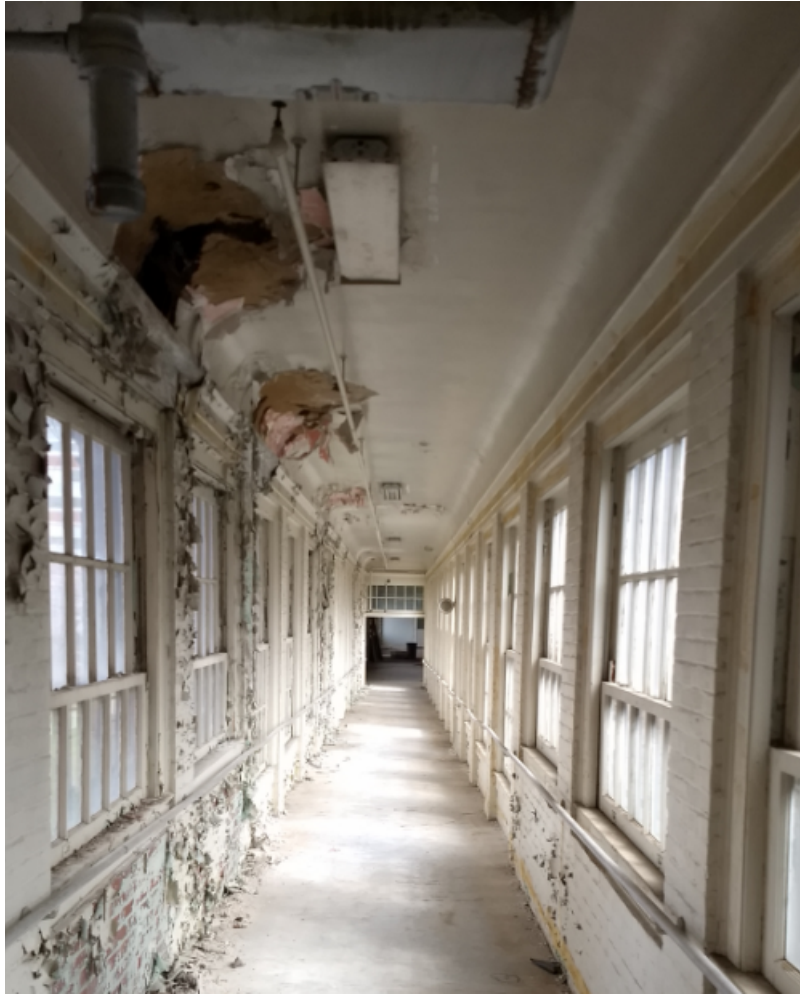
FIGURE 54: MESS HALL CORRIDOR SHOWING SIGNS OF WATER INFILTRATION AND ROOF DAMAGE
