Final Phase I Environmental Site Assessment

Armed Forces Retirement Home-Main Campus

3700 N. Capitol Street
Washington, DC 20011

January 2005

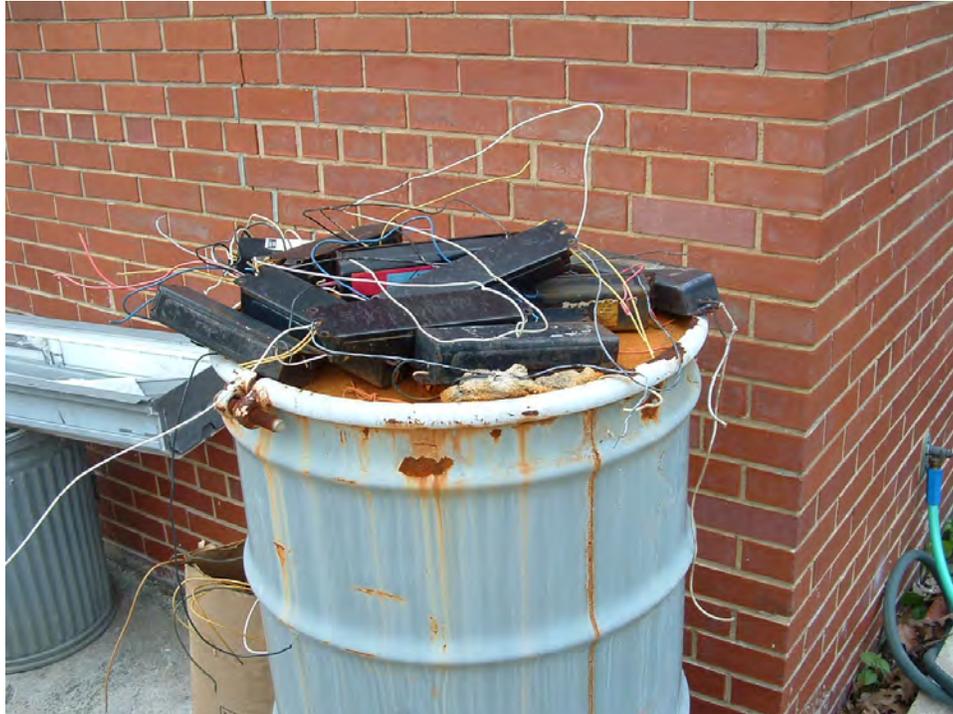
Mr. Edwards described the operations associated with Building 72, which houses the Paint Shop and the Electric Shop. Spent fluorescent lamps from throughout the AFRH are collected in Building 72, where they are boxed and then taken off-site for recycling. PCB ballasts are removed from fluorescent lighting during lighting replacement and stored in a drum at the northeast corner of Building 72. The PCB ballasts are picked up by the DRMO.

Photo 1: PCB ballast accumulation area outside of Building 72.

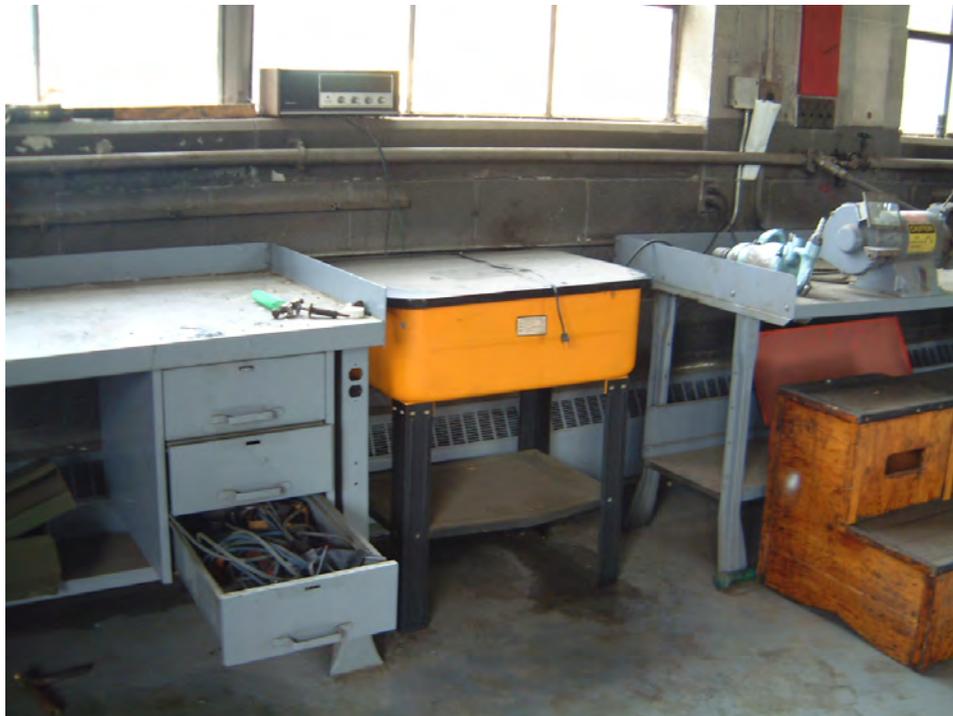
Photo 2: Abandoned parts cleaning station containing spent solvent waste in Building 73.

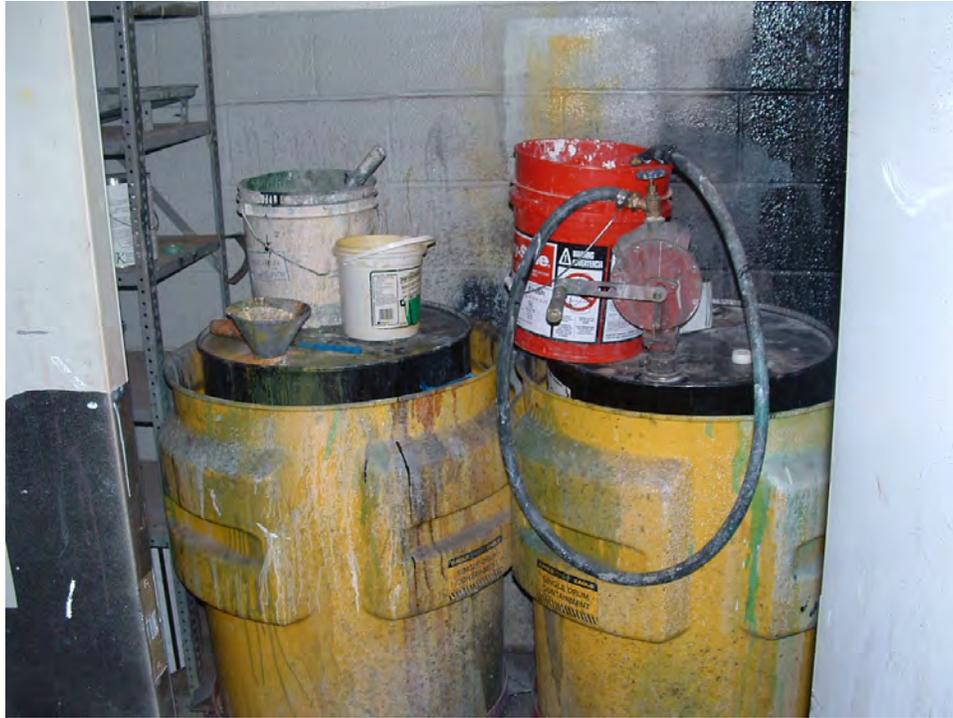
- A paint booth with a localized exhaust ventilation system is present in the Paint Shop in Building 72. The paint booth is reportedly no longer used. A drum for collection of paint waste and a second drum storing mineral spirits were found within an exhaust hood enclosure.

Photo 3: Drums containing paint waste and mineral spirits in paint shop area of Building 73.

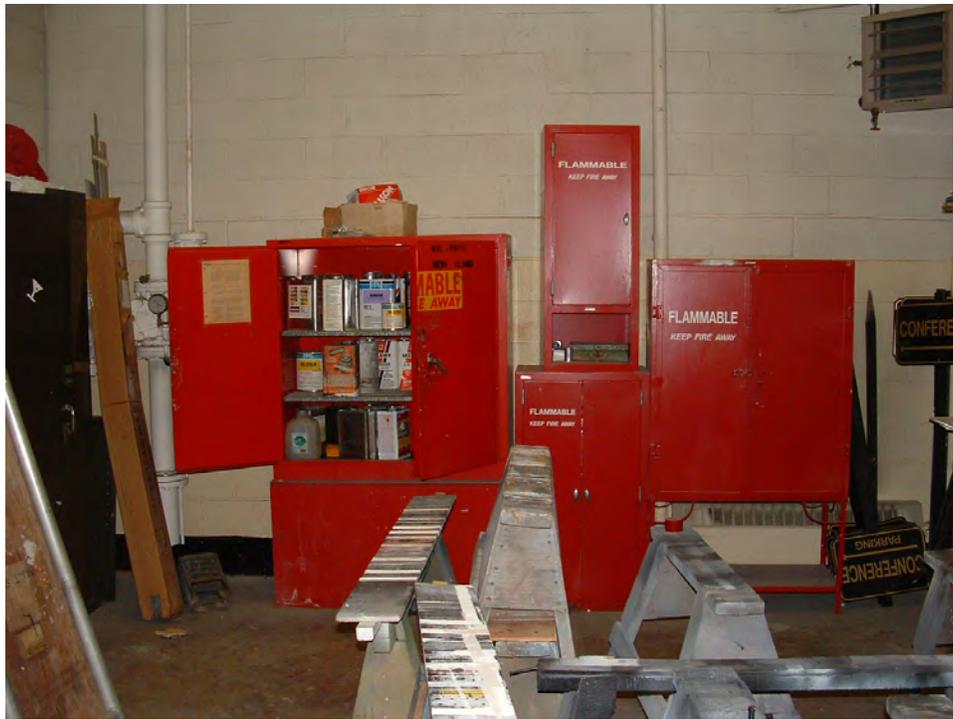
Photo 4: Paints, solvents, and adhesives stored in flammable materials cabinets in Building 73.

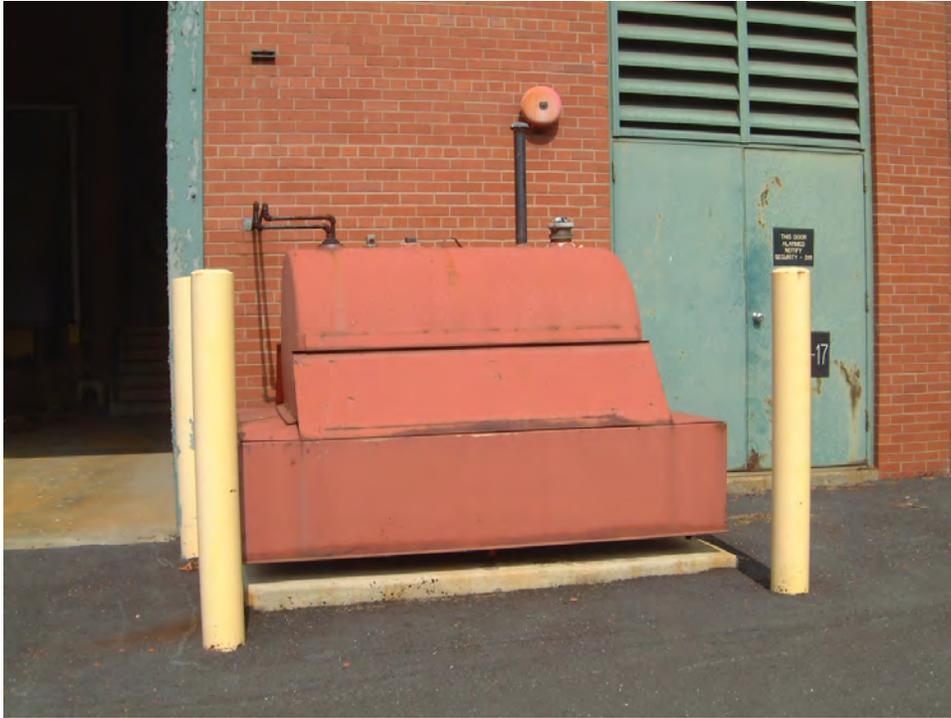
Photo 5: Above ground diesel storage tank for Building 74 emergency generator.

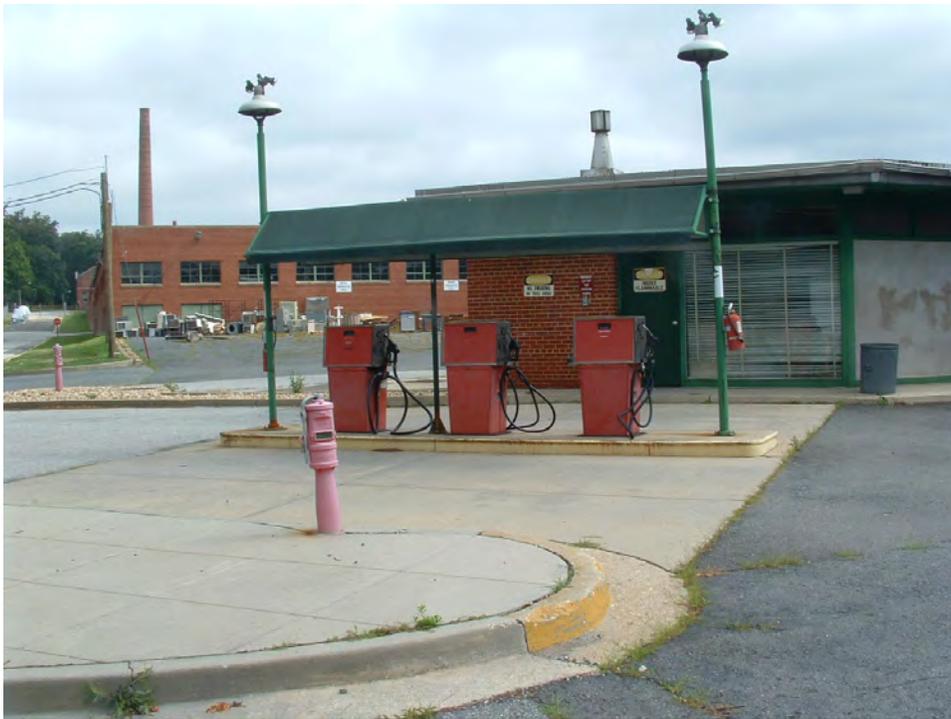
- Fill caps and vent piping for three USTs were noted immediately northwest of Building 75. According to interview information, the USTs included two gasoline and one diesel tank. The USTs are not in service.

- Three (3) USTs were recently taken out of service at the former vehicle refueling station (Building 75). According to interview information, the USTs included two (2) gasoline and one diesel UST. Out of service USTs that have not been properly closed represent a recognized environmental condition.

Photo 6: Former refueling facility at Building 75.

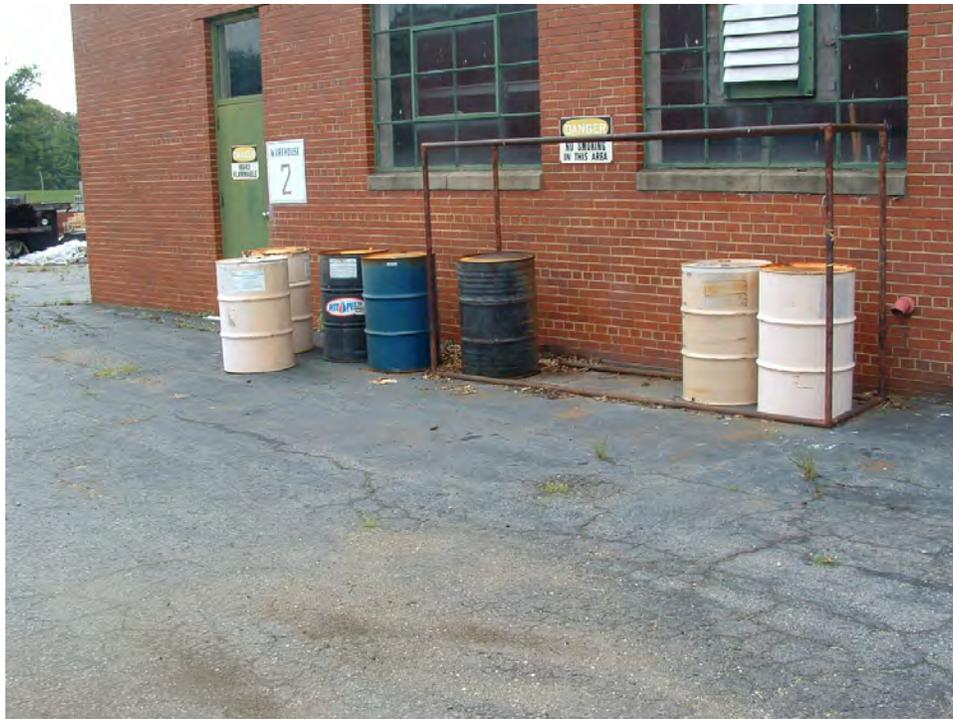
Photo 7: Drums containing unidentified liquid waste outside of Building 75.

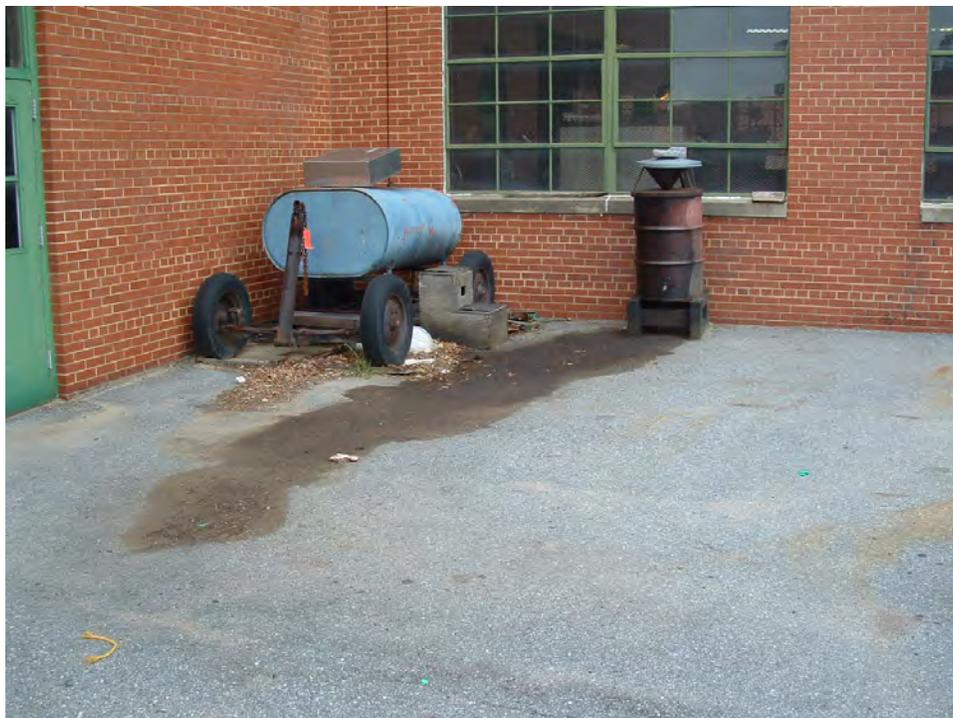
- Waste oil is also collected/stored in a 275-gallon AST and in a 55-gallon drum located outside Building 76, along the south wall. A dark stain was noted on the asphalt pavement leading away from the 55-gallon drum. At the time of the

inspection, the drum had a funnel in the top and was filled to capacity. Neither the AST nor the drum had secondary containment. A stormwater inlet was noted in the parking lot between Building 76 and 77.

Photo 8: Waste oil collection area at exterior of Building 76.

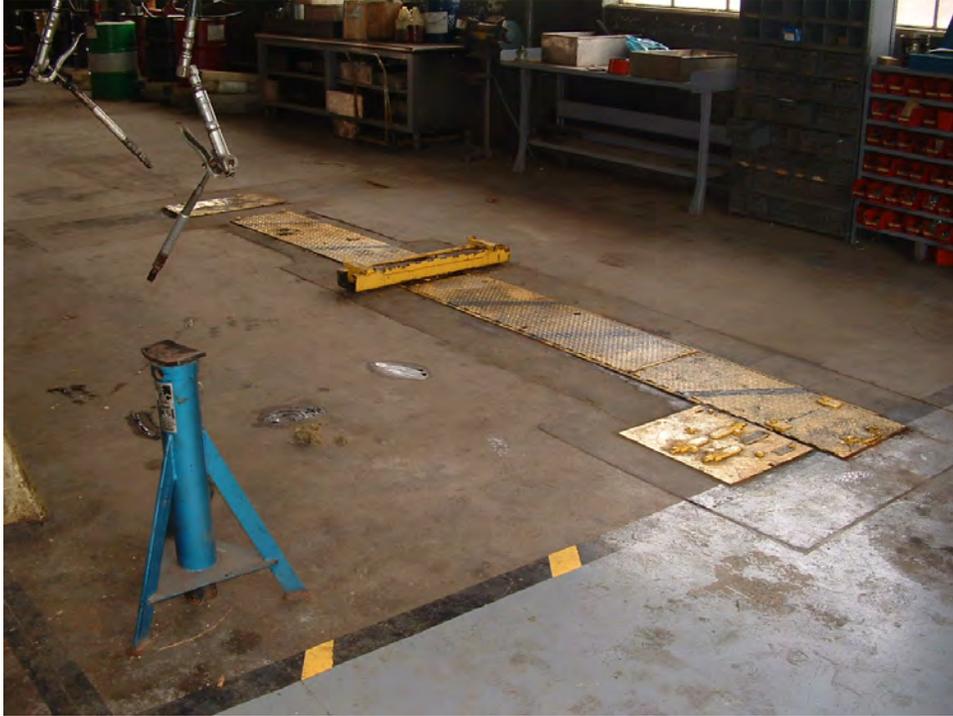
Hydraulic fluid in abandoned vehicle lift system could also contain PCBs. Hydraulic lifts were noted in the shop buildings 76 and 77.

Photo 9: Abandoned hydraulic lifts in Building 76.

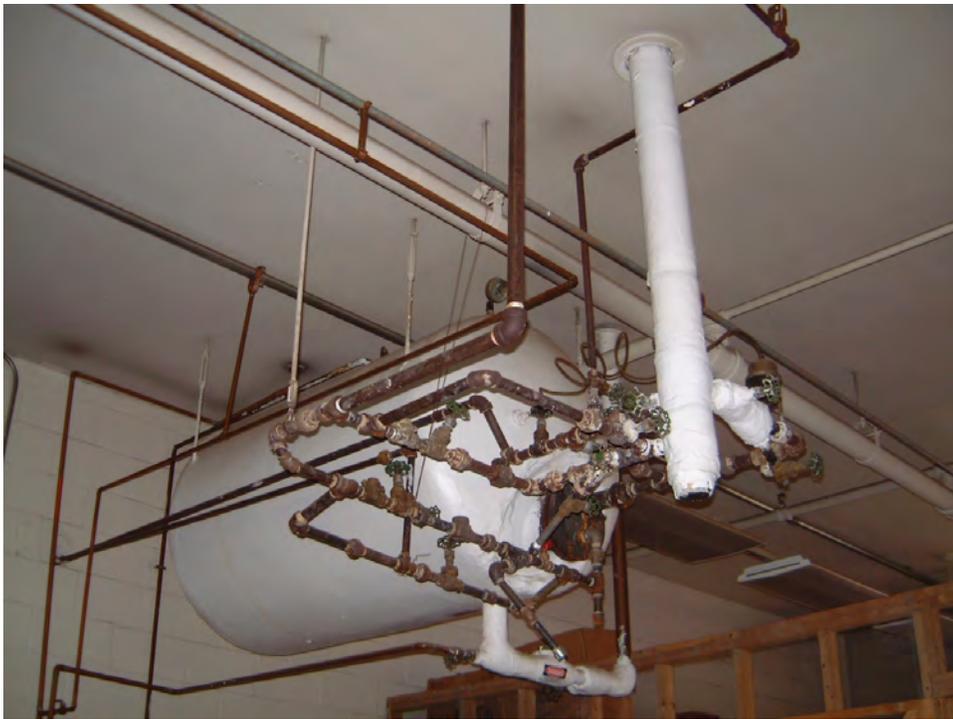
- Suspect asbestos insulation was noted on a hot water tank in Building 77. Asbestos insulation is assumed to be present associated with mud pipe fittings throughout the buildings in the Service Area buildings.

Photo 10: Asbestos insulation on piping and hot water tank in Building 77.

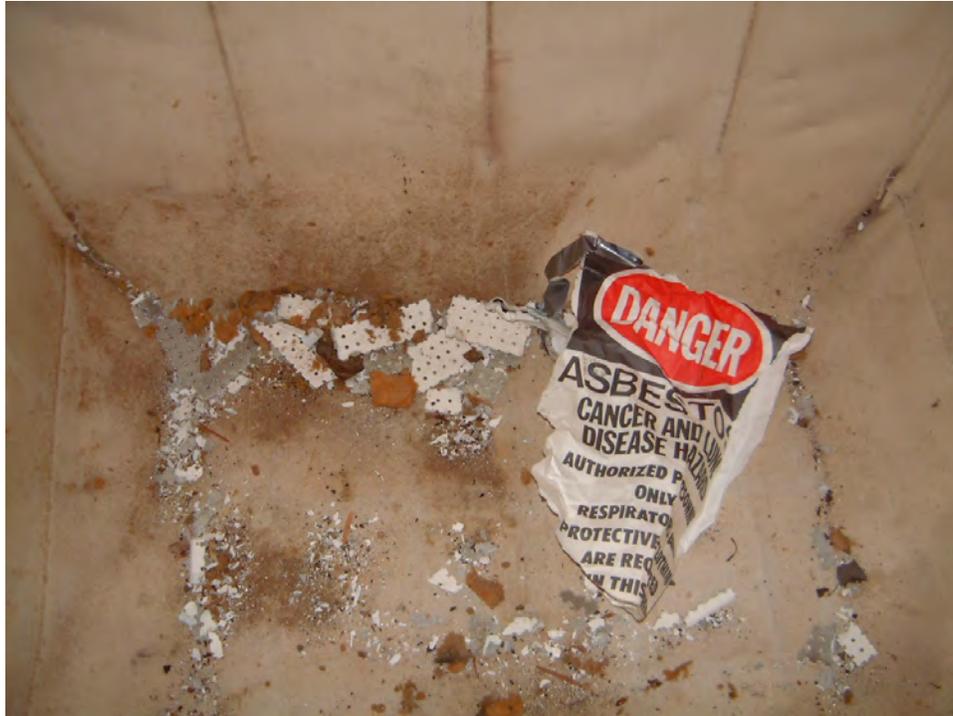
- Asbestos-containing debris was noted in laundry hampers adjacent to the remaining laundry equipment in Building 46. Asbestos warning signs were also noted in the hampers.

Photo 11: Asbestos debris in hamper in former laundry facility of Building 46.

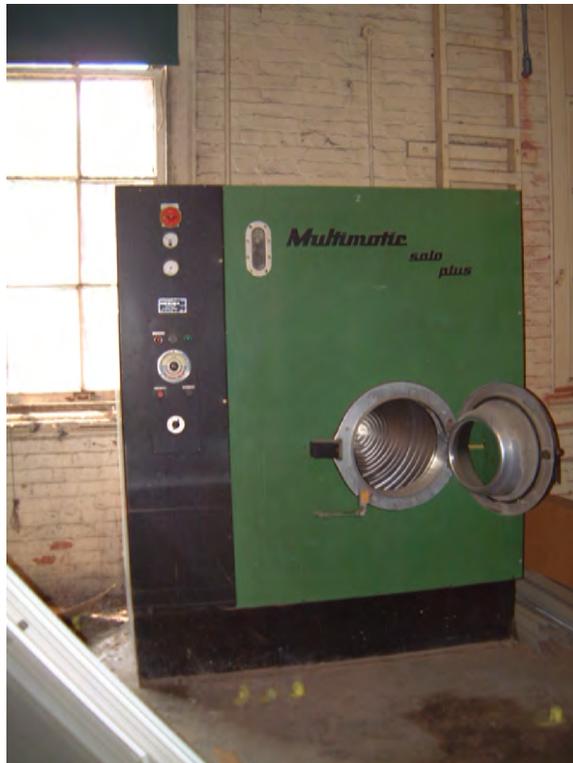
- Two (2) suspect dry cleaning machines were noted in the former laundry facility in Building 46. The machines appear to be dry-to-dry type machines and are not of recent manufacture. No evidence of perchloroethylene (PERC) solvent or waste was observed.

- The western portion of Building 46 was formerly a laundry facility, which reportedly ceased operations in the 1990s. Two suspect dry cleaning machines were noted in the partially gutted former laundry facility. The prior ESA report indicates that historical dry cleaning operations were suspected for the laundry facility based on an assessment of waste generation information. The presence of a dry cleaning operation and potential for release of solvent wastes represents a recognized environmental condition.

Photo 12: Suspect dry cleaning machine in former laundry area of Building 46.

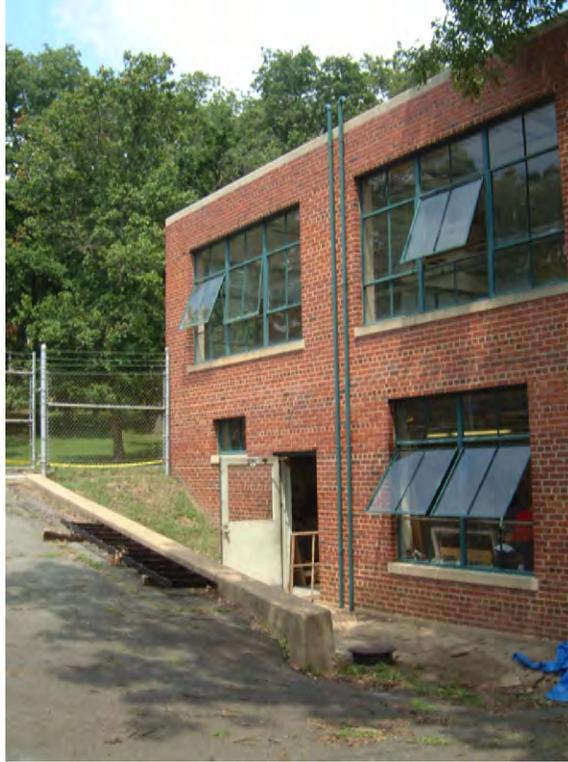
- Extensive accumulations of bird excrement were noted on surfaces in the upper level of the laundry in Building 46.
- A two story addition is attached to the southwest corner of Building 46. Two (2) vent pipes were observed along the south façade of this addition. The piping and an adjacent suspect fill cap are possibly associated with abandoned UST system(s).

Photo 13: Suspect abandoned UST location at south side of Building 46.

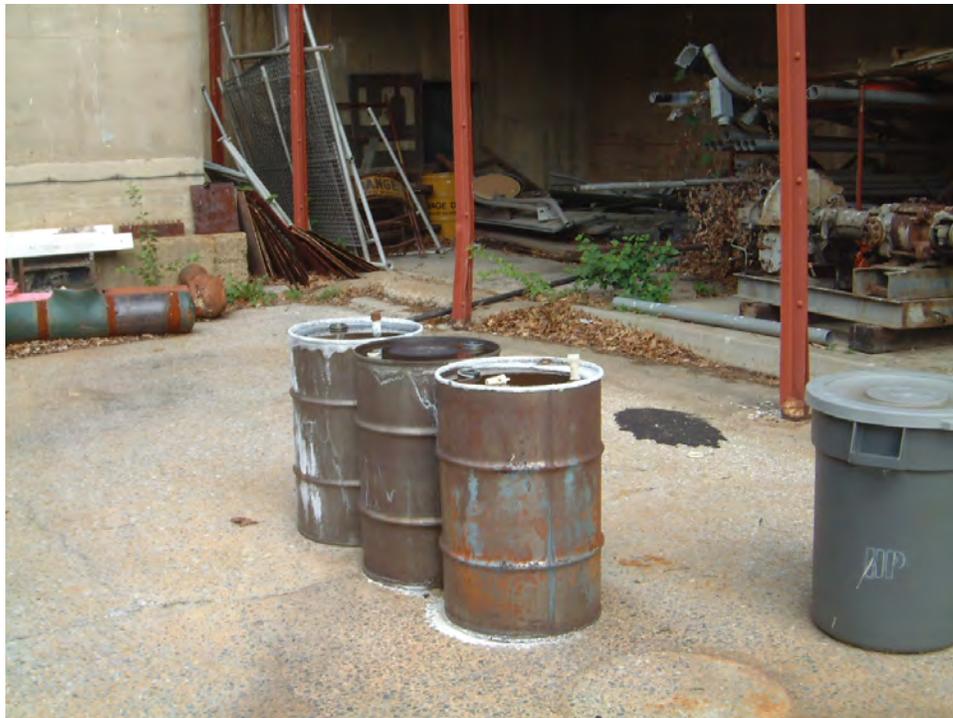
- Three (3) 30-gallon drums of unknown liquid waste were noted in the outdoor storage lot associated with Building 46. Workers indicated that the drums have been there for many months if not years. A white granular deposition or crystallization was noted on the exterior of the unlabelled drums, possibly indicating reactive or corrosive waste is contained in the drums.

Photo 14: Corroded drums containing unidentified liquid waste at Building 46.

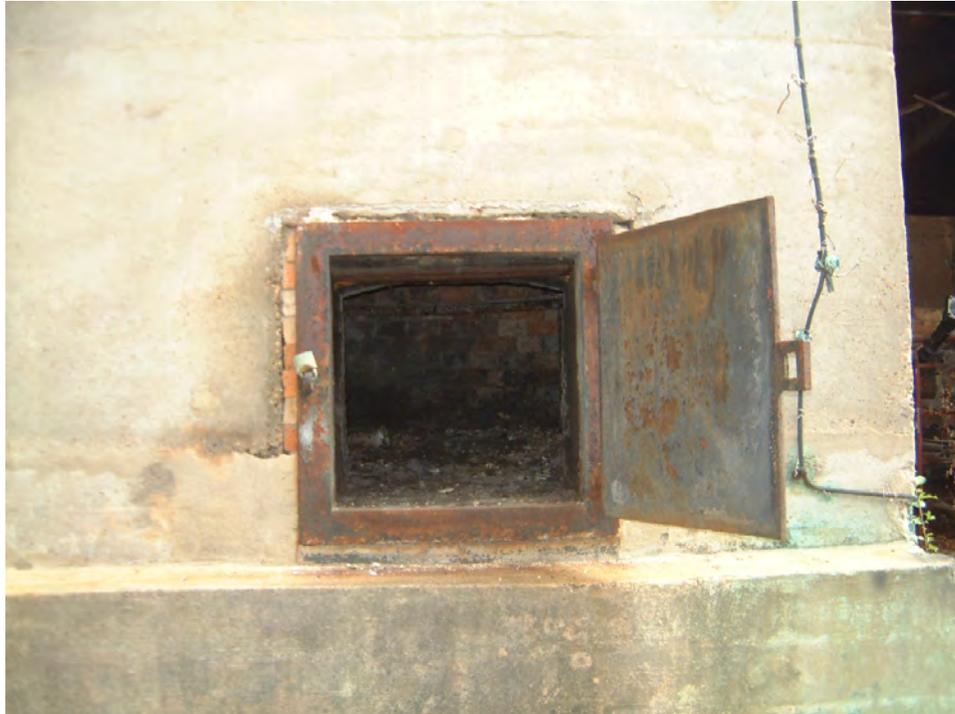
- Building 69 is a vacant two level structure at the northern end of the Heating Plant. A sign on the front of Building 69 identifies the building as the (former) hazardous waste storage building. An obsolete incinerator is associated with Building 69. It could not be determined when the incinerator was in operation or what materials were burned. Ash was noted on the bottom of the internal chamber of the incinerator from three access doors at the lower level of the building and one door outside the building.

Photo 15: Incinerator near Building 69.
