RE: Additional Phase II Environmental Site Assessment (ESA) at Buildings 46 and 76  
**Armed Forces Retirement Home (AFRH) - Main Campus**  
3700 N. Capital Street, NW  
Washington, DC 20011  
CGS Project No. CG-17-1111  
Building 46: FACILITY ID #: 4010007/LUSTCASE #: 2018010  
Building 76: FACILITY ID #: 4010008/LUSTCASE #: 2018011

**Additional Phase II  
Environmental Site Assessment (ESA)  
at Buildings 46 and 76  
Armed Forces Retirement Home (AFRH)  
Main Campus  
3700 N. Capital Street, NW  
Washington, DC 20011**

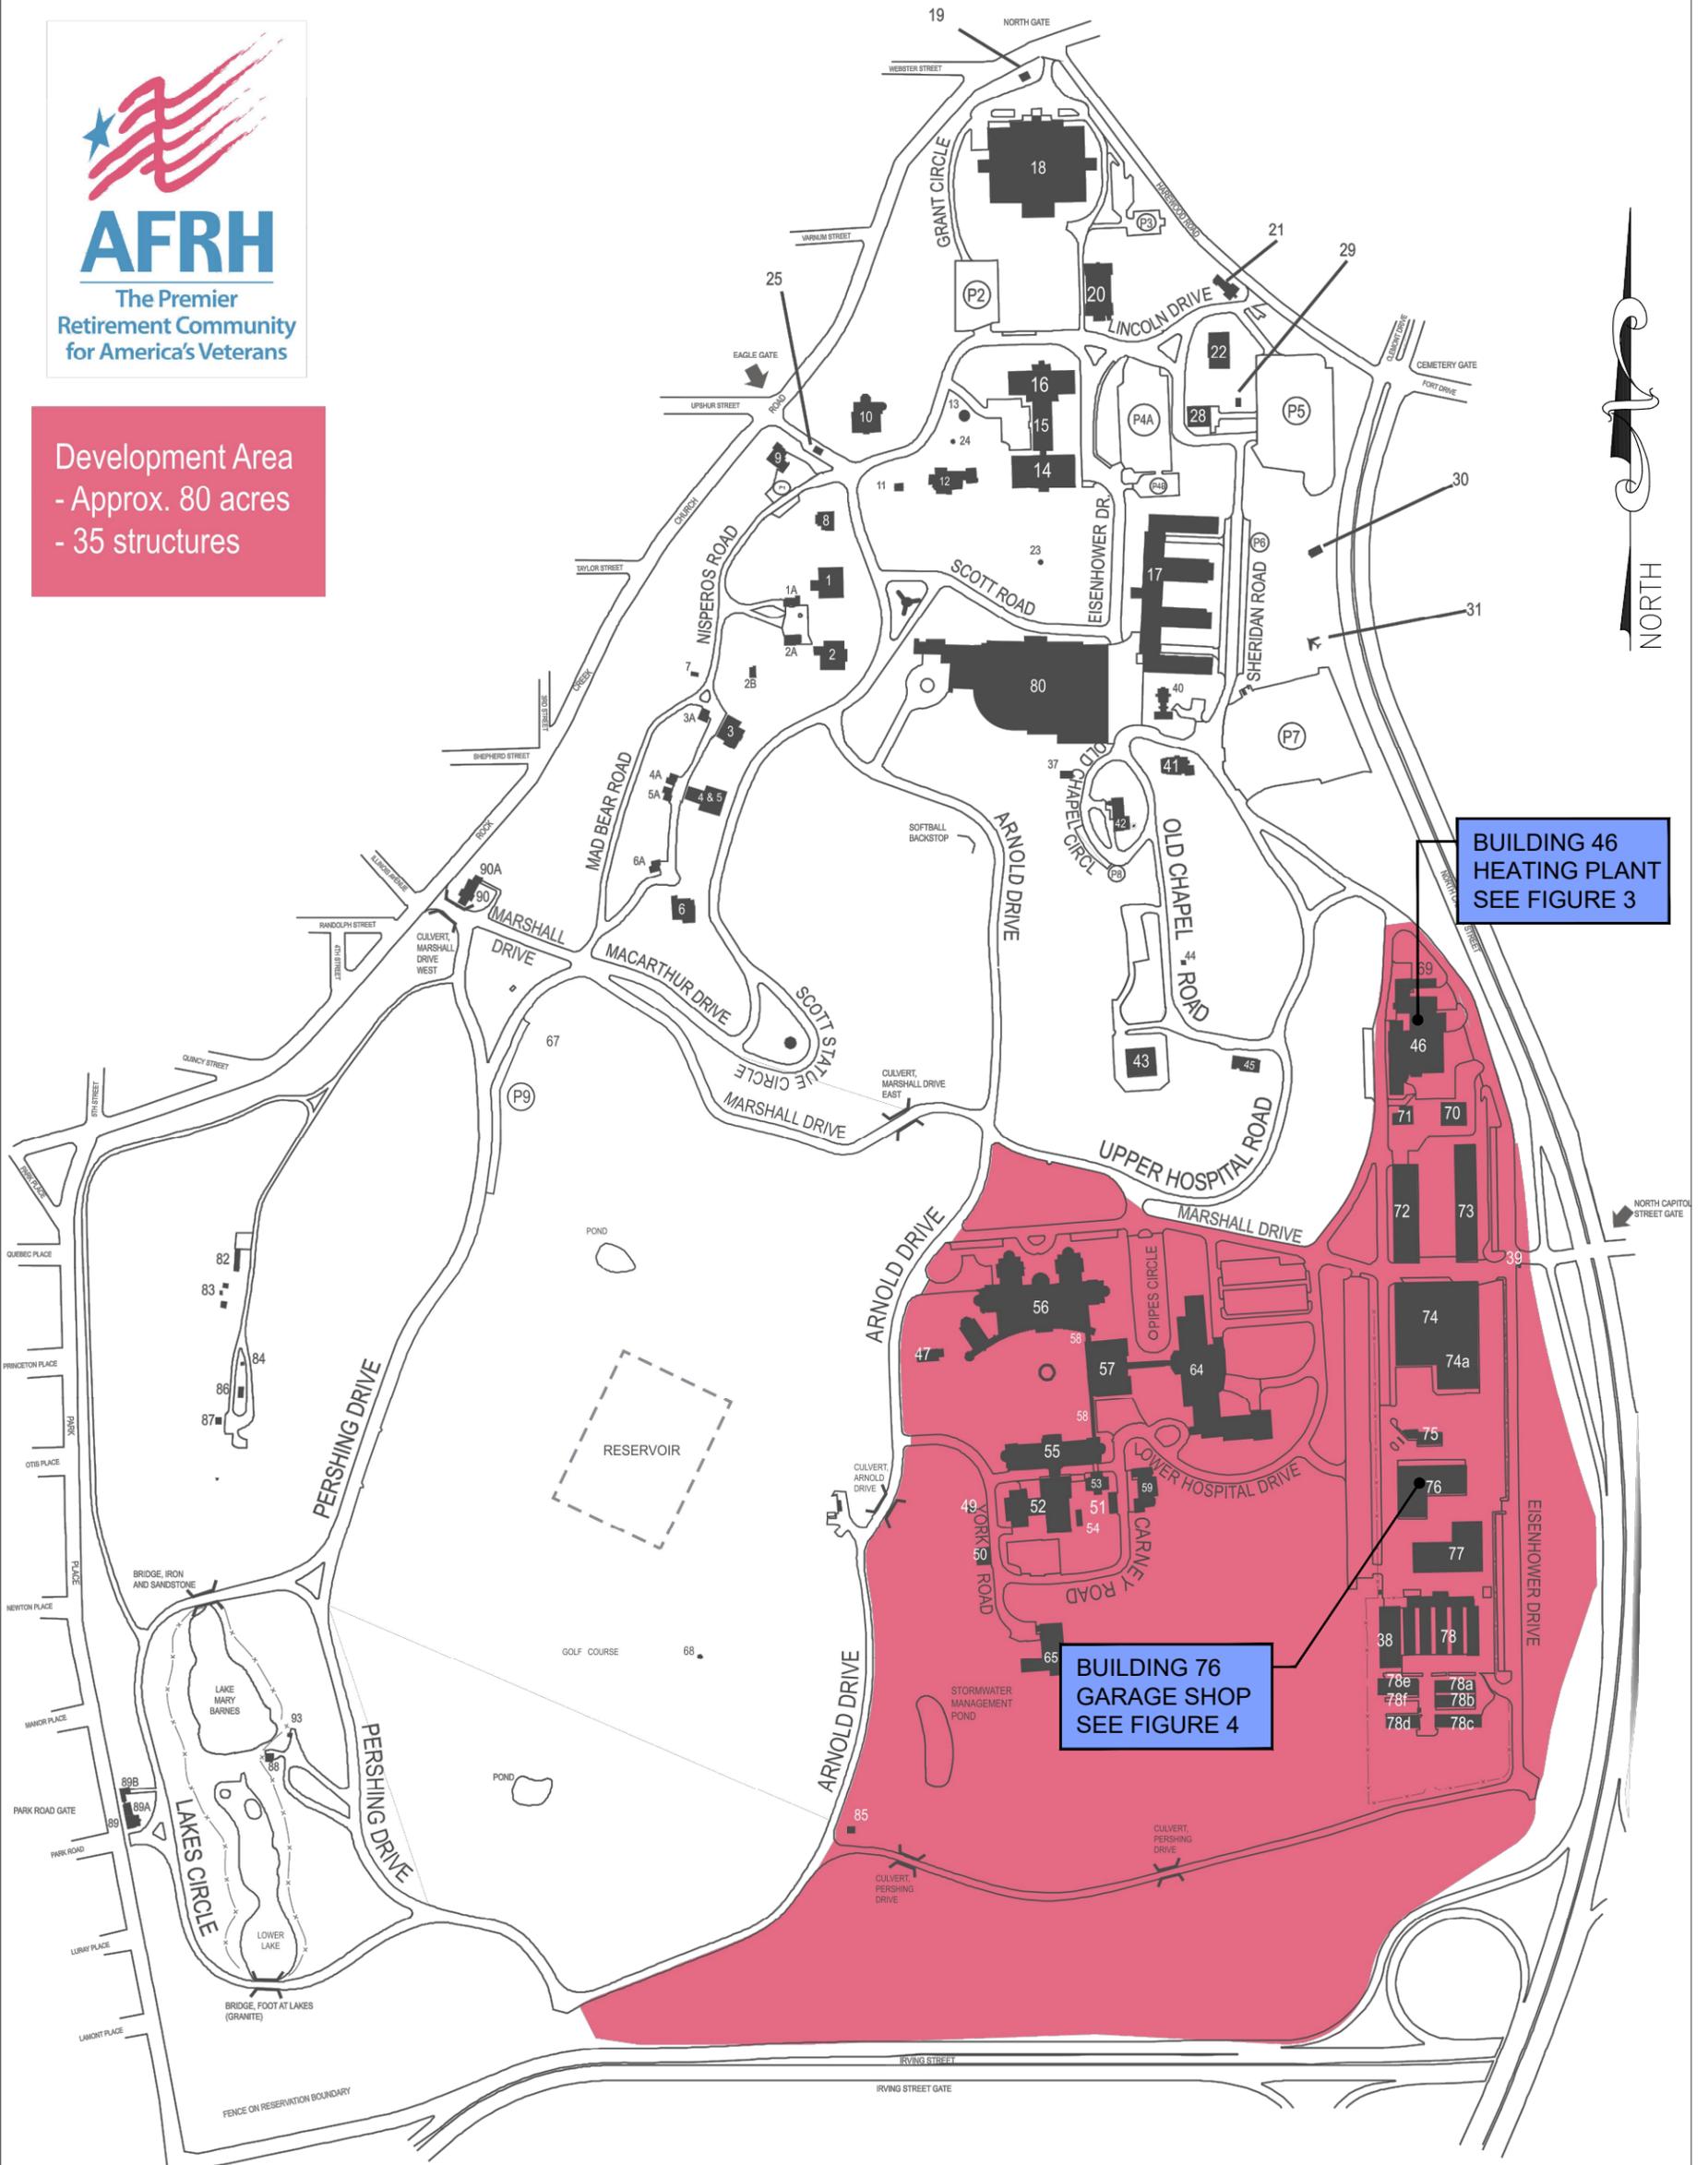
**Figure 2**

"A ridgeline and drainage divide extends north-south, [in the vicinity of Buildings 51 through 58 as shown on **Figure 2**] and directs surface flow to the east or west. Surface water on the [development parcel] infiltrates the ground surface or flows to the storm sewer system. The western portion of the [development parcel] drains to a combined sanitary and storm drain sewer system that runs down the center of the AFRH campus. The combined sewer system connects to the District of Columbia's system at Irving Street and flows to the Blue Plains wastewater treatment plant. Some storm water is also collected in an on-site storm water management pond located southwest of Building 65. The eastern portion of the [development parcel] drains to a storm drain system, which flows south and connects to a 30-inch pipe under Irving Street near the North Capitol Street interchange. This pipe is part of the District of Columbia's storm drain system."

**Site Layout Map**  
**Armed Forces Retirement Home**  
**Additional Phase II Environmental Site Assessment**  
**3700 N Capitol St, NW Washington, DC 20011**

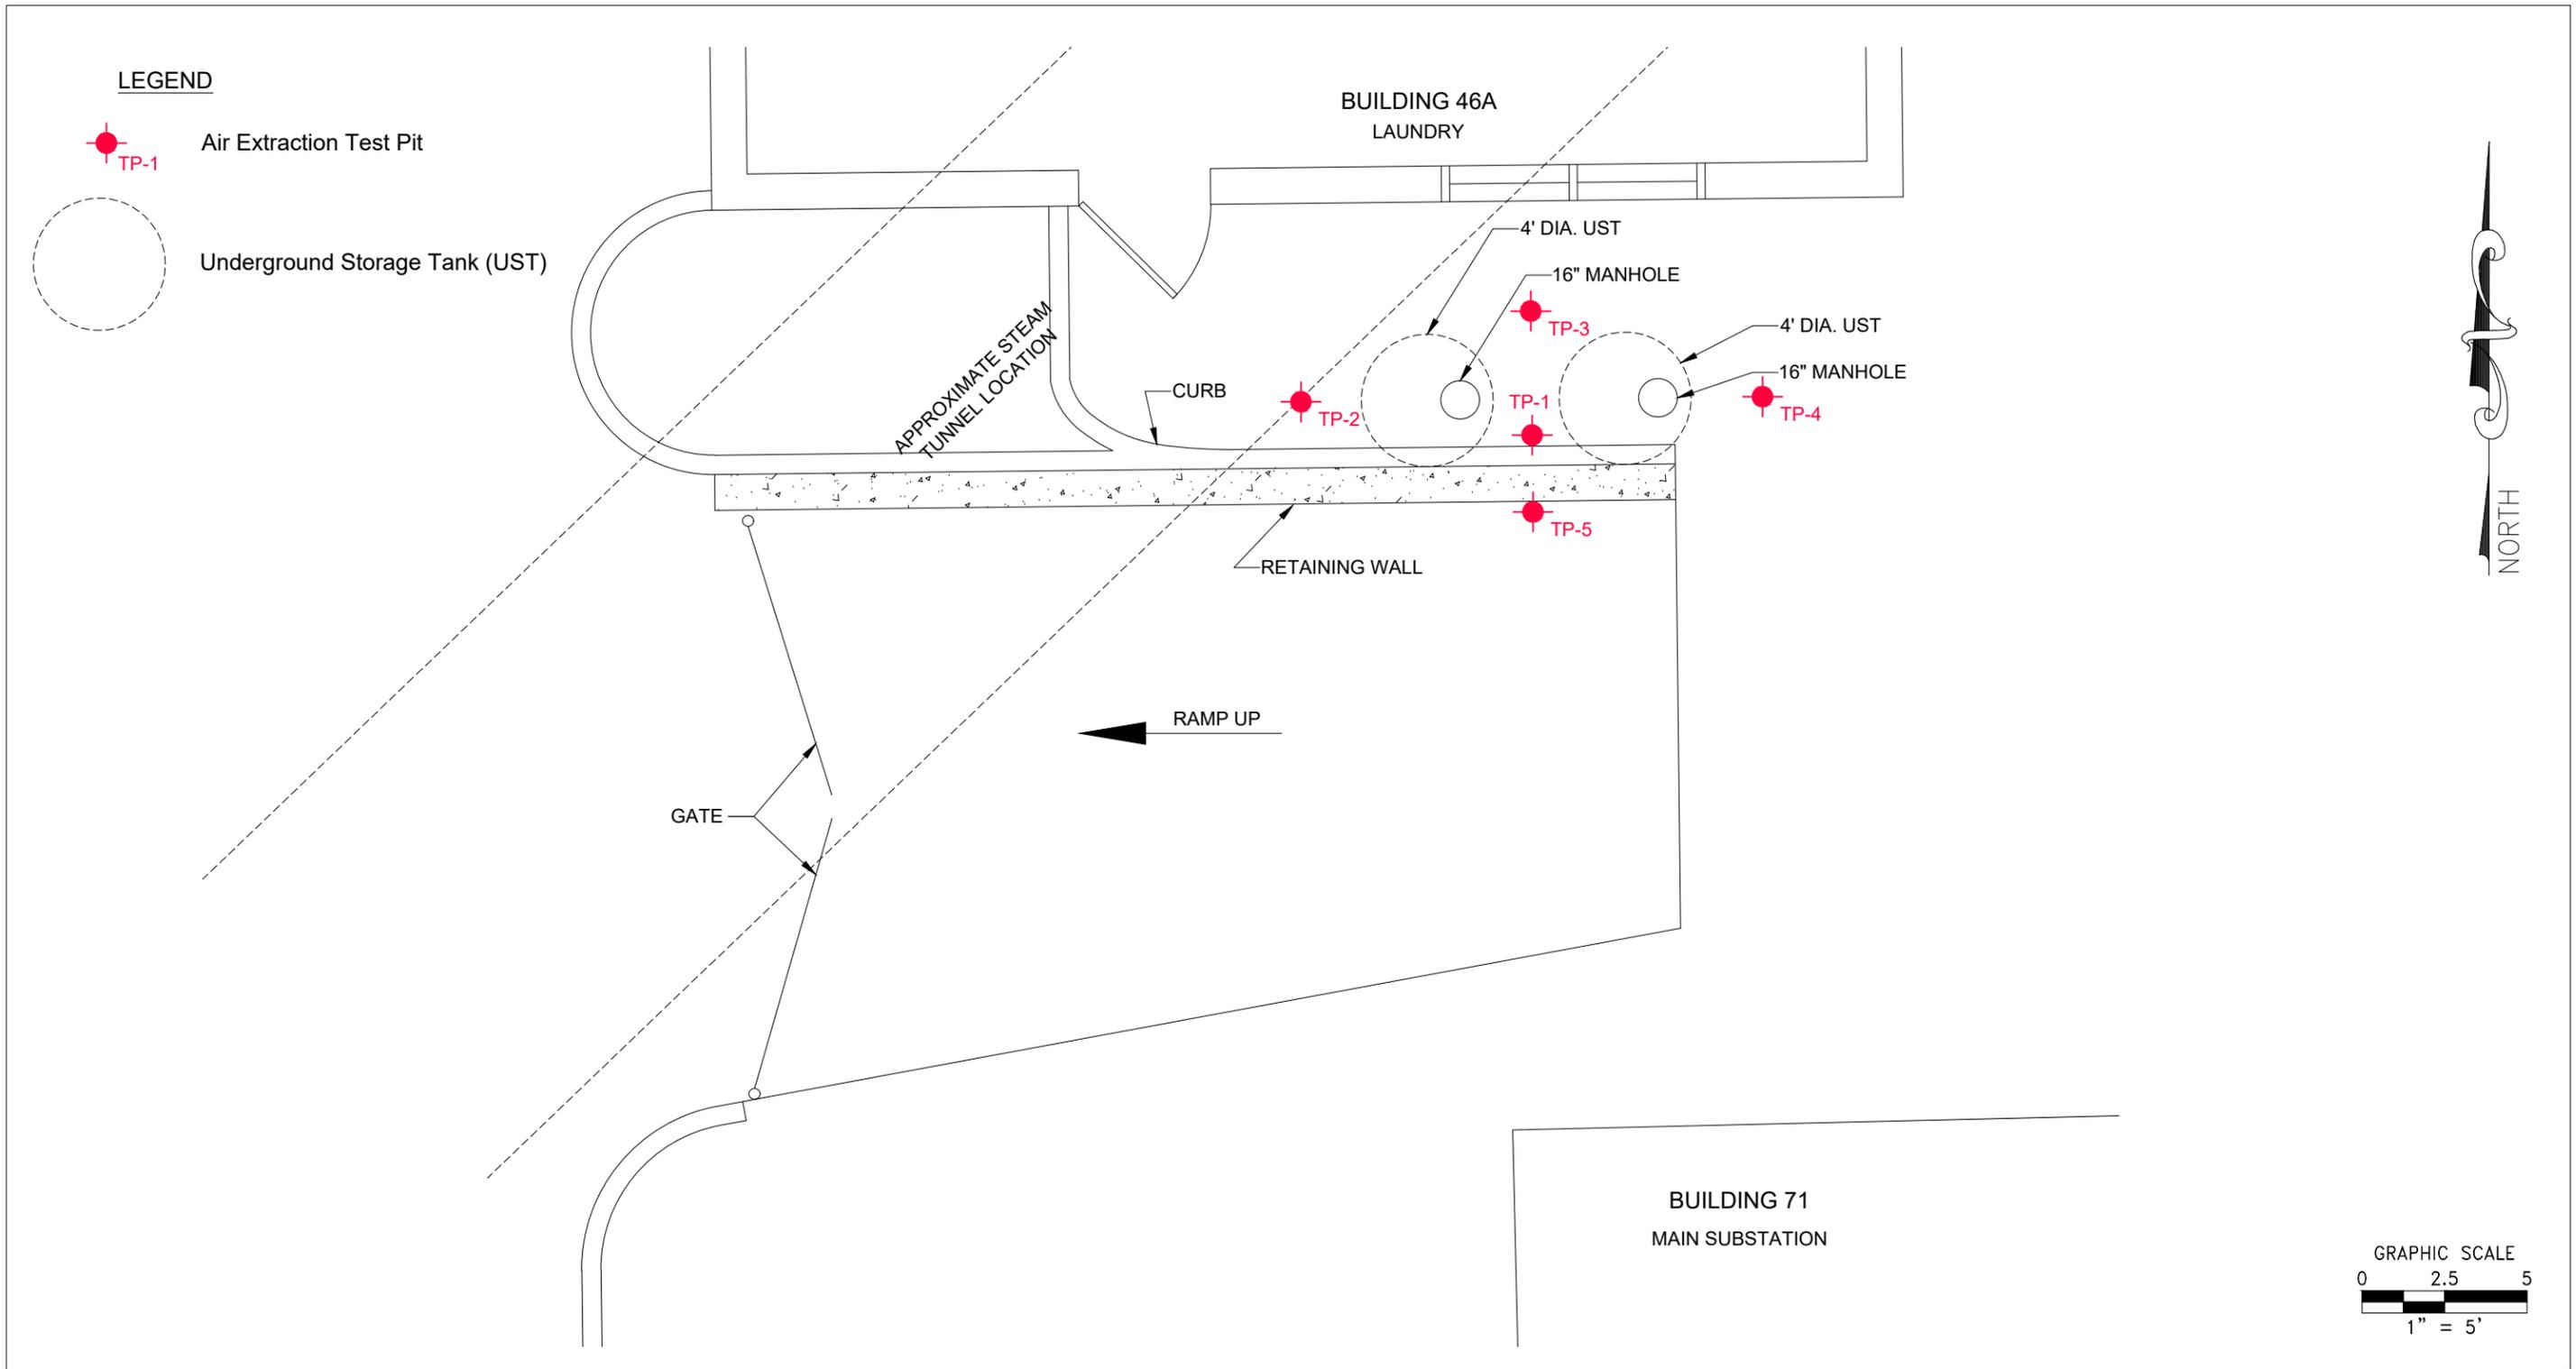
Figure 6

Based on the volume of water removed, the USTs were determined to have a capacity of 275-gallons each. On November 9, 2017, five air extraction test pits were advanced around the USTs to clear underground utilities and to map out the foundations of the building wall and the retaining wall located on either side of the tanks (**Figure 6**).

CGS used the services of Mr. Carson E. Mok, a licensed structural engineer in DC, to inspect the USTs and surrounding structures to determine if the USTs could safely be removed. The findings from advancing the five air extraction test pits were provided to Mr. Mok. He concluded that the two USTs could not be safely removed, because the foundation of the retaining wall would be undermined and that the tanks should be abandoned in place. Mr. Mok's report and foundation drawings are included in **Appendix D**.

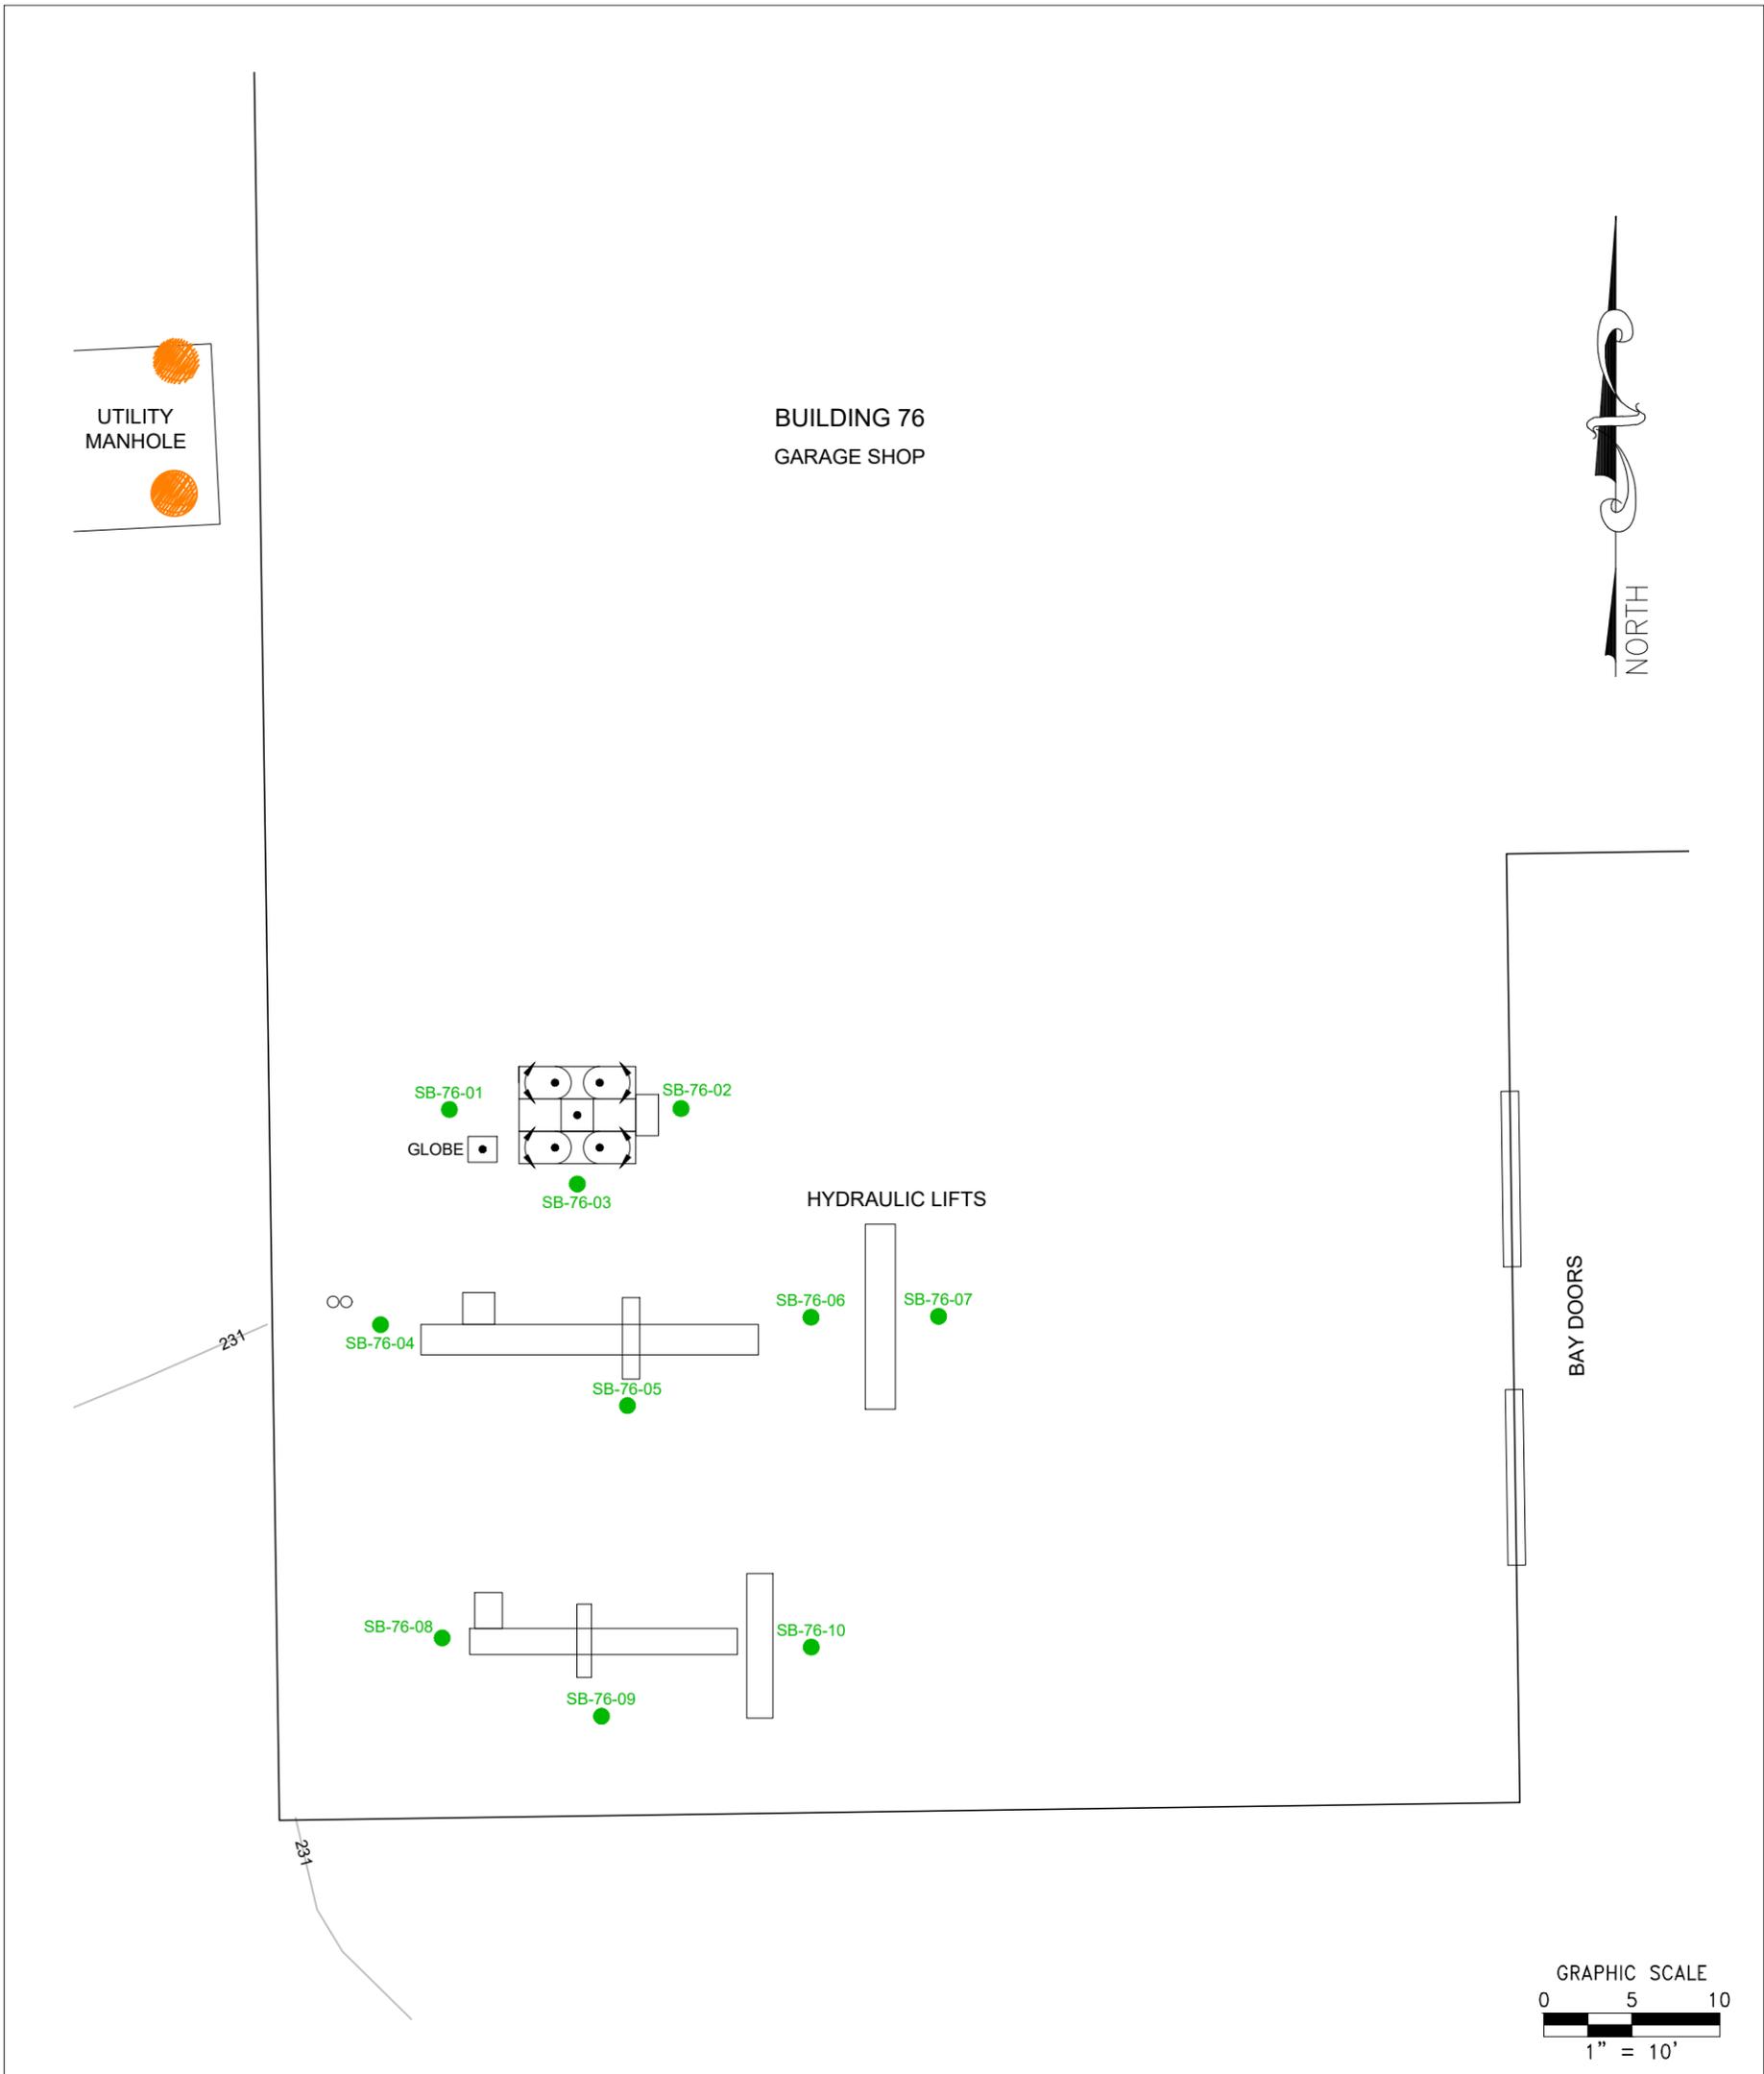
Figure 8

The Building 76 soil borings (SB-76-01 through SB-76-10) were advanced at the locations shown on **Figure 8** on April 27 and 30, 2018. Information regarding the rationale for each soil boring location and the rationale for collecting soil samples from each boring are listed in **Appendix E, Table 1**. Staining on/cracks in the concrete slab and/or evidence of surface soil contamination was observed at SB-76-01, SB-76-03, SB-76-06, SB-76-09, and SB-76-10. As discussed above in Section 2.3, concrete coring for these borings was performed in areas where these observations were made.
